## Description and Analysis of the Fabric of the Barn at Holyfield Farm, Holyfield, Waltham Abbey, Essex. 20th March 2009.

### **General Description.**

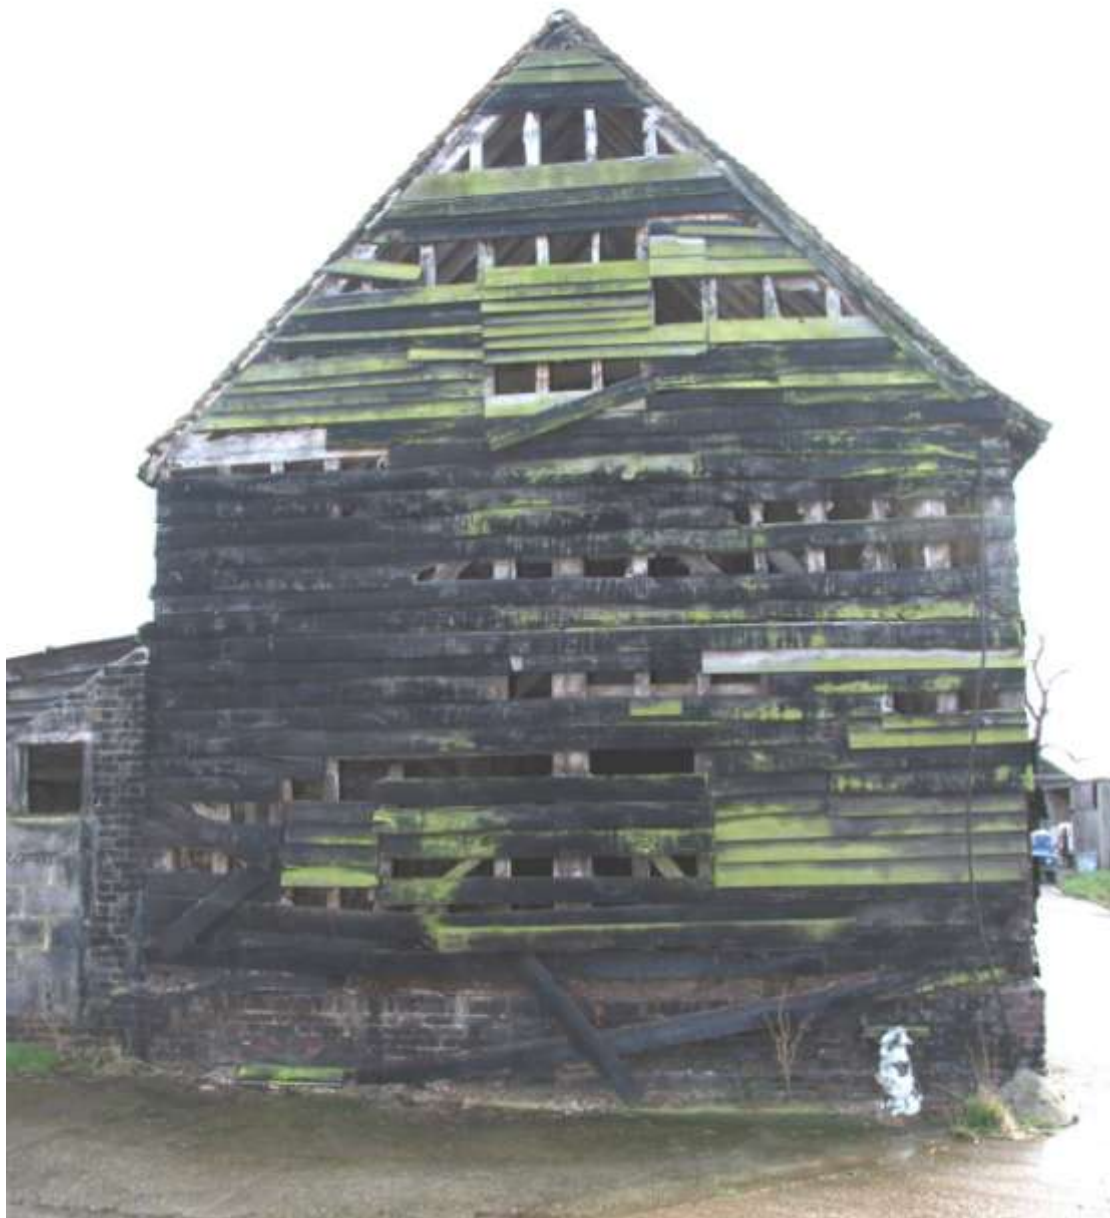
The northern elevation is in poor condition having lost much of its boarding.

The northern elevation consists of the gable end of the barn together with a small outshot to the east. The barn elevation is 6.0m wide, 5.0m to the eaves and approx 8.25m to the ridge on the outside. The wall is composed of a narrow section timber frame set on a red brick plinth. The frame is visible from the outside due to the loss of several of the weather-boards.

The timber-frame is clad in weather-boards of two distinct types - modern machine sawn feather edge boards secured with galvanised french nails and painted with cold brushing tar - and much older, thin section, possibly riven boards secured with wrought iron rose headed nails. These were coated in hot tar with their edges defined by many droplets. It is evident they have not been tarred for a long while. There are many additional modern nails.

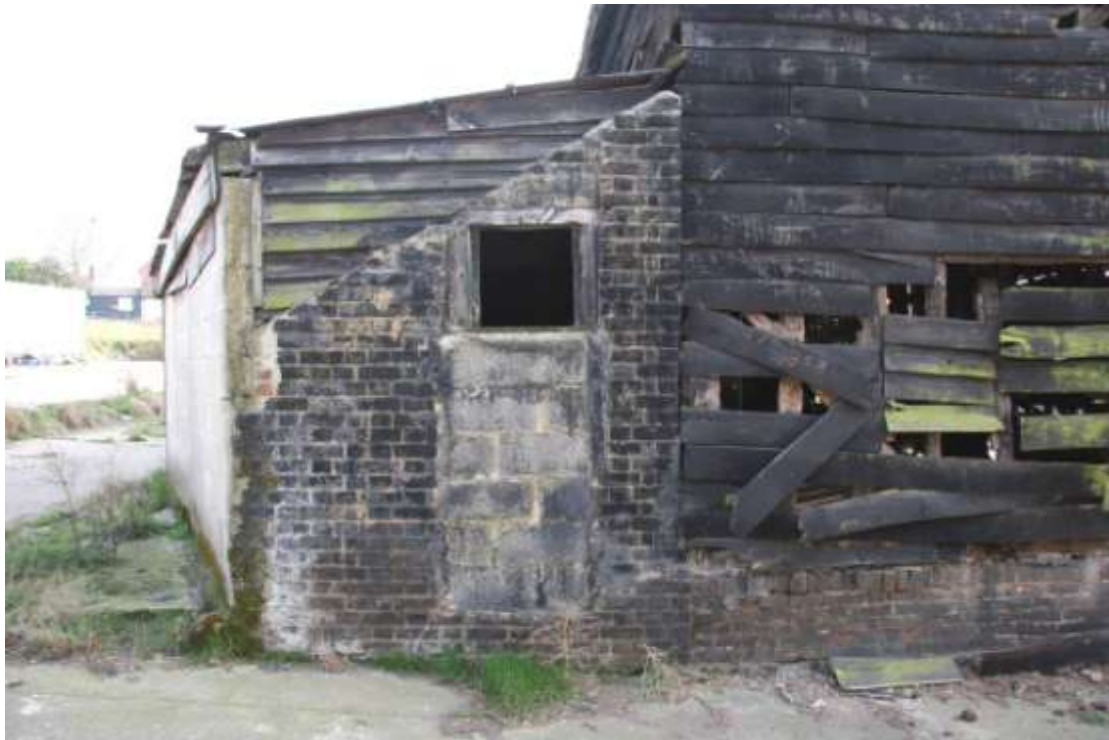
The flat-roofed outshot was originally smaller with a steeper pent roof.

The outshot was originally much smaller than today and was built of yellow London Stock bricks (65x100x230mm) in the northern wall. The southern wall was shared with the larger Central Outshot which is entirely timber-framed but lined to waist height in brick. The outshot was essentially a roofed enclosure using the existing barn wall to build off.

The northern elevation had a narrow door with a high threshold, which has been filled with breeze blocks and a small window created. The building was evidently quite shallow at the front of its former 45 degree pitched roof and was originally rectangular in plan. It was likely a pig pen.

The eastern corner has been removed and the building finished in breeze blocks to create a wider turning arc for modern farm machinery . (Mr David Chapman - pers comm). The opportunity was taken to increase the head height by inserting a wedge of modern studwork and placing a ramshackle corrugated iron roof on top at a near flat pitch. Inside is a date in the render of 28 Nov 94. It was used as a chicken house.

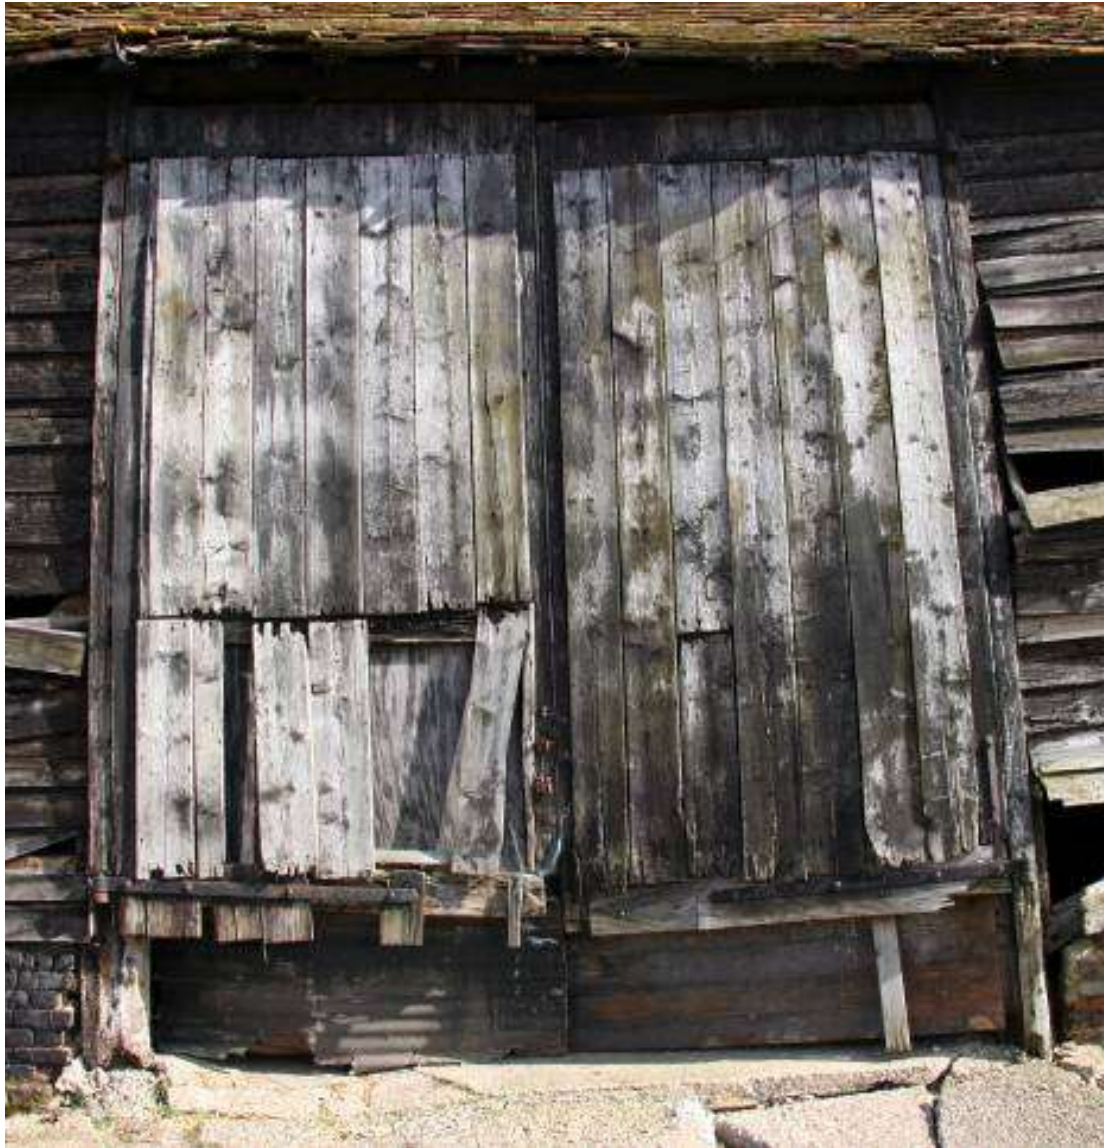
The northern doors have had their bases removed and a makeshift barrier put in place.

The pair of doors to the north has had its bottom section sawn or broken off and a makeshift barrier of corrugated iron and an old door put in place in imitation of a leap or lower leaf. However there are no apparent fixings to indicate a predecessor. The northernmost leaf has been previously repaired in the C20th with a large let-in lower section. The doors and their frames were prone to being damaged by modern tractors. (Mr David Chapman - pers comm).

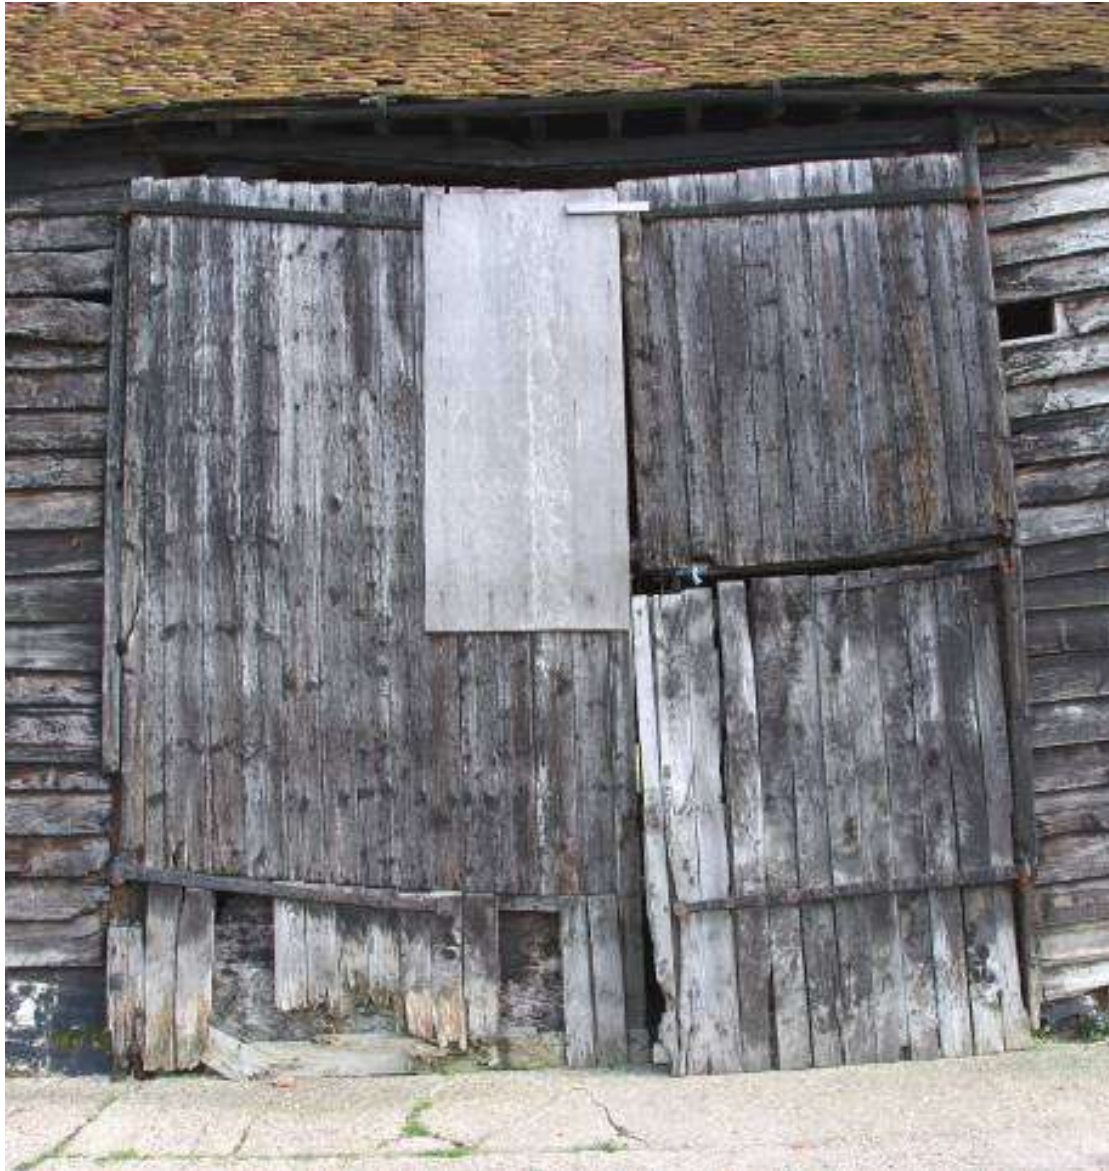
The southern barn doors have a smaller pedestrian door cut into them.

The southern barn doors are more complete and of the same C20th construction. The southernmost leaf has been sawn in half to create a lower door for pedestrian access into the barn. Its partner shows the same damage to its lower section as that to the other pair of doors and this is mostly caused by the doors falling on their hinges and dragging on the concrete surface.

Both doors retain their drop bars and the sockets for them indicate that they were always in this position. The very long pintle strap hinges with spoon terminals may possibly be reused from the C19th century but the fittings are modern.

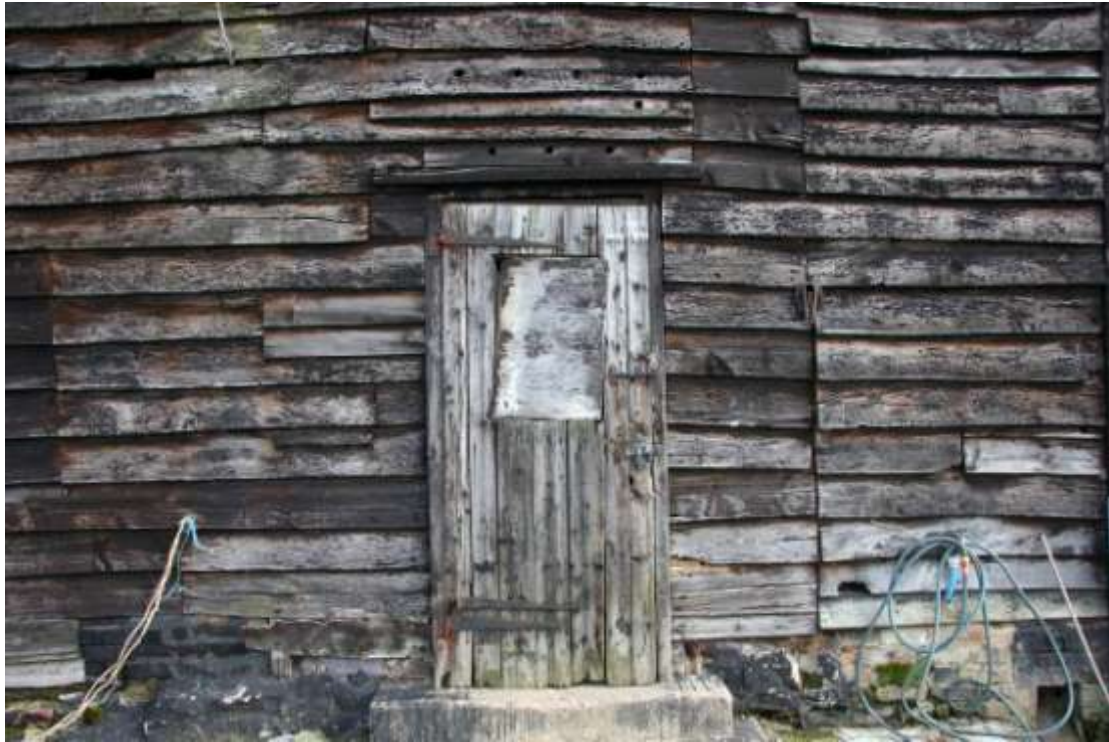
The C20th door into the Cleaning Room.

There is a gate and ledger construction plank door into the southernmost bay (Bay 10, the Cleaning Room). This is also C20th and in poor condition. Originally there was a glass panel which has been replaced with an offcut board. There are two wrought iron T-strap hinges with spooned terminals which are C18th-C19th in character and probably served an earlier door. The lower one is broken and replaced with a mild steel T-strap hinge. The latch and hasp are C21st.

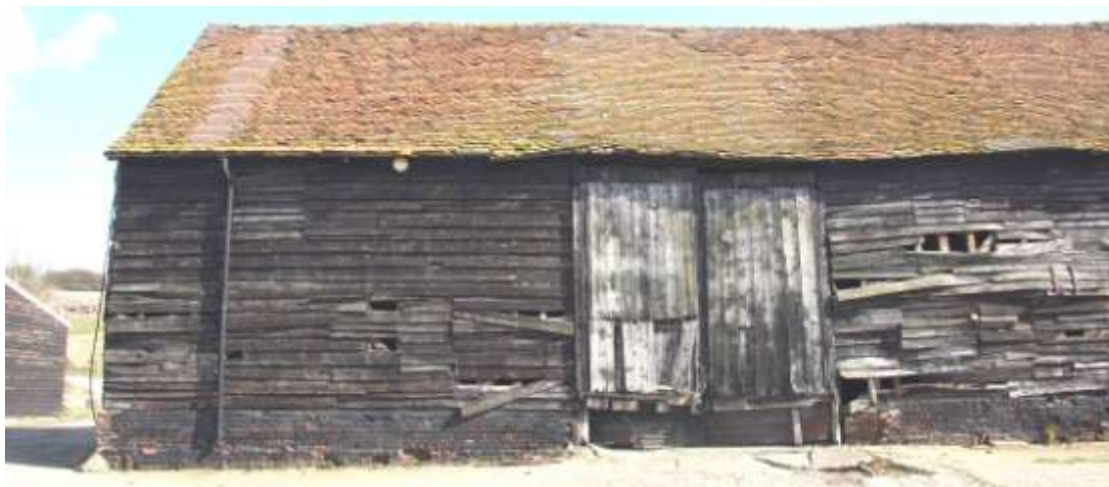
The position of redundant windows is denoted by short sections of modern weatherboards.

There are two blocked in openings that have remnants of frames on the inside to denote earlier windows. One is below the eaves in Bay 1 and the other similarly positioned in Bay 5.

There are also other blocked in apertures in Bay 2 at eyelevel, Bay 4 at eaves height and Bay 5 at eye level. There are also a number of other small sections that may represent earlier openings but their context has been lost by extensive repairs to the frame particularly in Bays 6 and 7. The openings appear to have all been blocked in the C20th with short pieces of narrow section machined softwood feather edged boards.

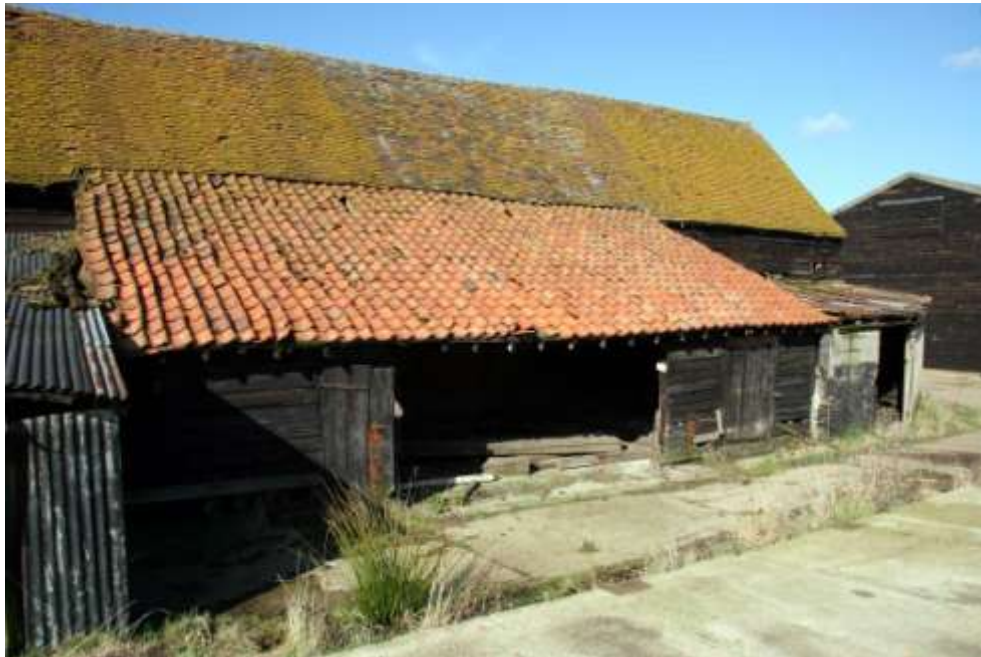
The Central Outshot has a pan-tiled roof constructed in the C20th.

The Central Outshot is constructed in the main of C20th timber with machined softwood rafters supporting a pan-tiled roof. The wall to the north is constructed of re-used studwork clad in old weatherboards and may be contemporary with the barn while the other walls are all C20th machined softwood with some vernacular additions.

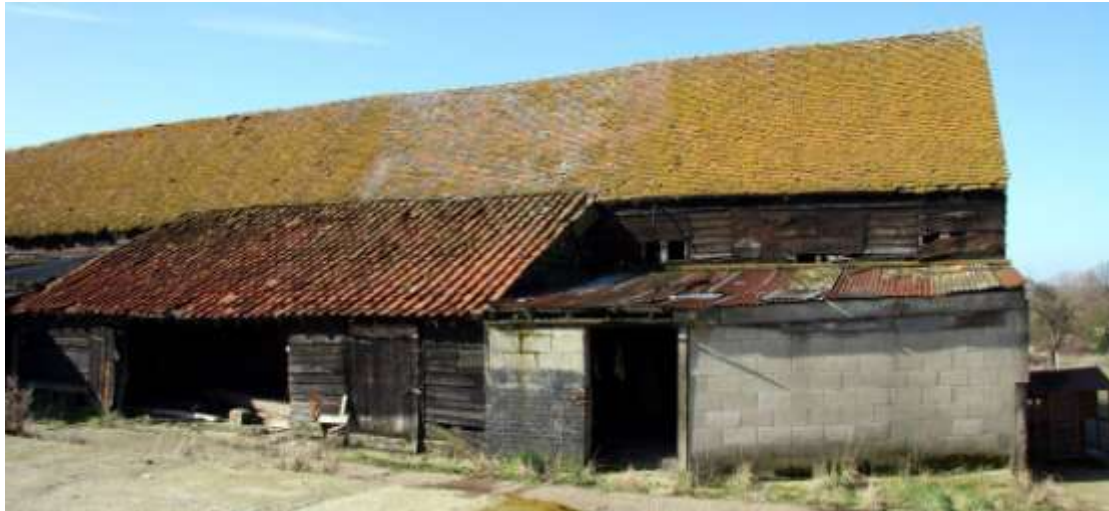
The Flat-roofed Outshot from the east showing the tin roof and breeze block wall.

The Flat-roofed Outshot is the development of a smaller unit built of yellow London Stock bricks. The original unit was smaller with a low fronted steep pitched roof and a waist height brick wall probably to form a pen for pigs. The height has been increased by inserting a breeze block wall and a small section of studwork and dropping the pitch of the roof which is now clad in rusty corrugated iron sheets. Inside the roof has been clad with fibre board.

The plan of the building was changed to allow a greater turning arc for modern farm vehicles and the work was done in November 1994.

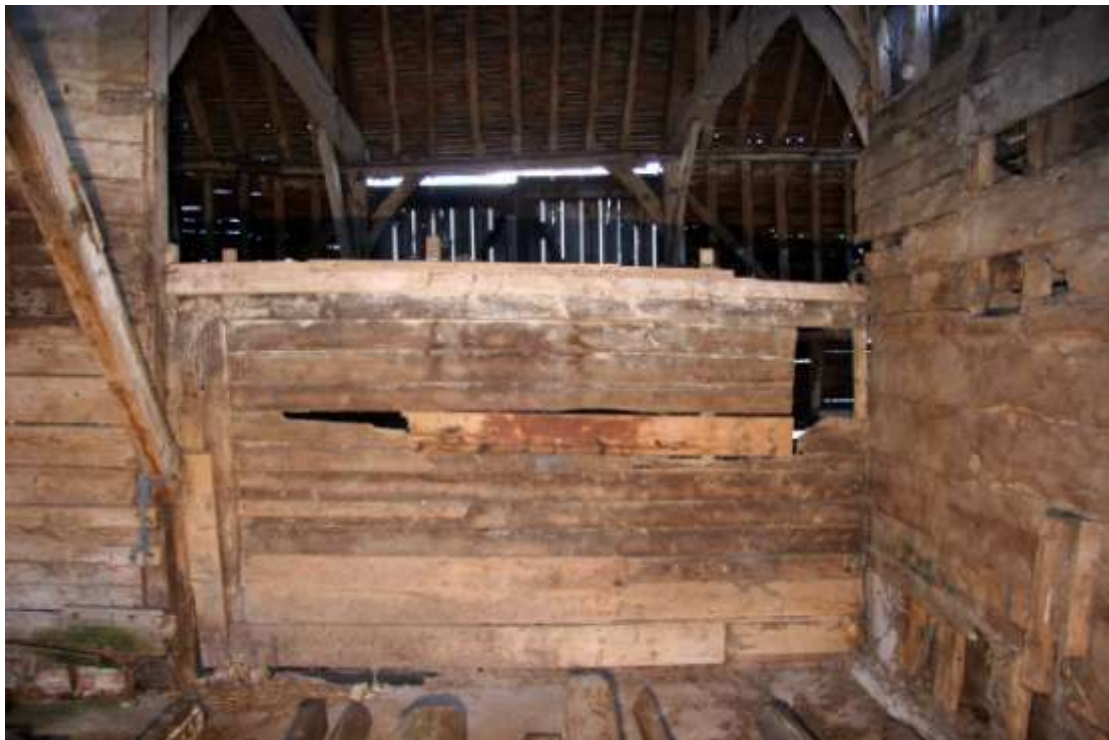
C20th vernacular partition between the barn and the Central Outshot constructed by Mr Chapman senior.

There is a ramshackle division between the Central Outshot and the barn which was constructed by Mr David Chapman's father which sits where the barn doors should be. However there are no fixings for doors on the main posts and the Central Outshot may have always been here in some form since the barn was erected.

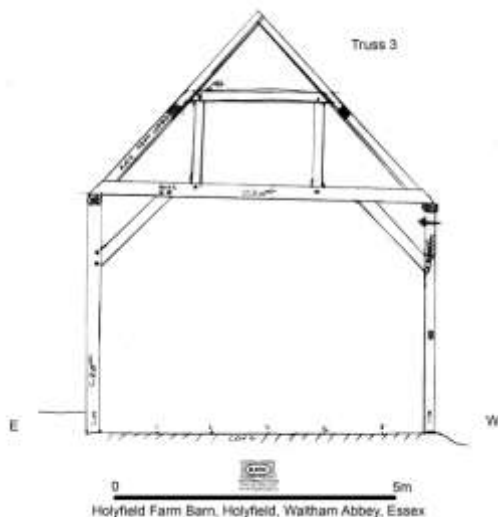
## Truss 3.

Truss 3 has been repaired with a straight cut C20th tie-beam supported with bolted on braces. The principal rafters are red softwood. The collar is marked with the number III.

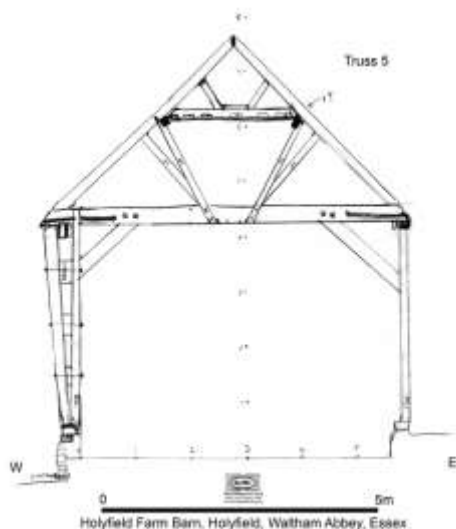
#### Truss 5.

Truss 5 has been highly repaired in the C20th including the replacement of the main tie-beam and the eastern principal post. A secondary principal post has been inserted at the western end to counteract the bowing out of the frame. This is connected with substantial iron bolts passed through large wedges of timber between the two posts.

There are four raking queen struts nailed in position, two of which take up the weight of the side purlins that pass into the southern part of the barn. It is at this point that the roof construction changes its character.

The collar is a reused timber with several out of place mortices including one directly into the principal rafter. It now supports two C20th short raking struts above inserted to arrest the failing principal rafters which have split at this point. There are two empty mortices for a shorter collar immediately above the current one. At this point there is a single strike of a chisel point to represent number 1.

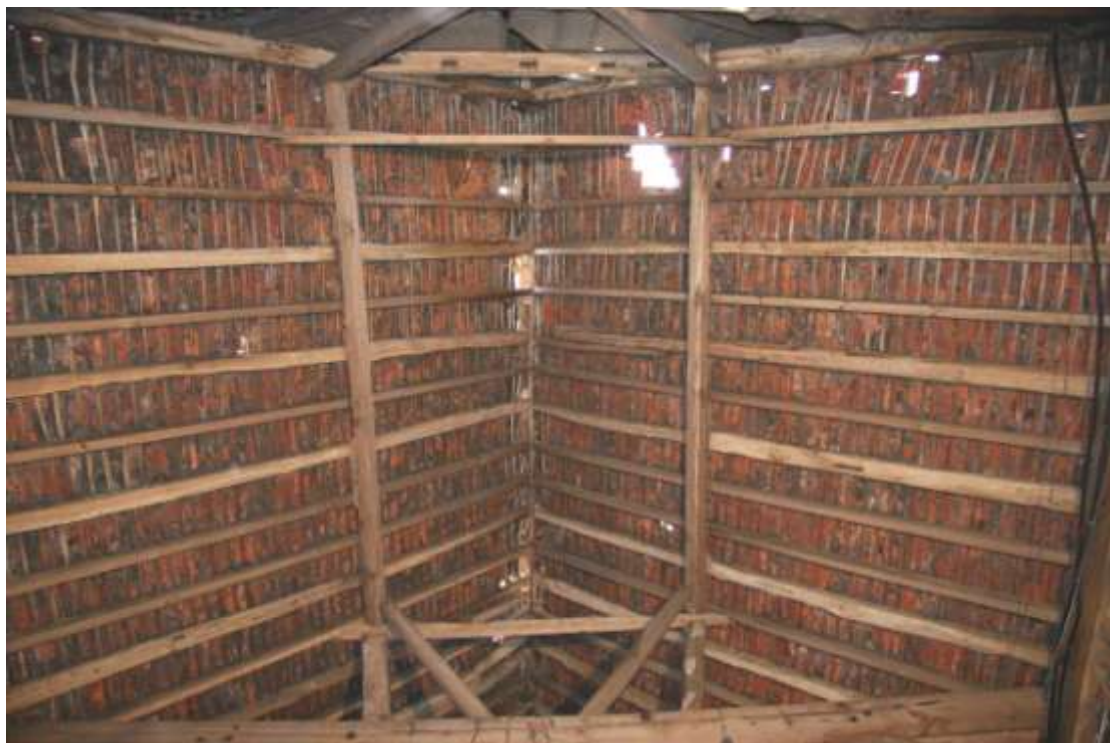
Bay 6 roof structure showing the many softwood replacements made in the C20th.

Bays 6-10 have a different character to Bays 1-5 in that they have a clasped purlin construction roof with full height rafters and no windbraces. The rafters are nailed onto a softwood ridgepiece. All of these bays have been rebuilt in the C20th century and contain much modern machined timber. As it is known the barn was seriously damaged in 1942 by an explosion it seems most likely that this is when the roof was remodelled.

In Bays 6 and 7 about 50% of the rafters have been replaced in C20th machined softwood whilst in Bay 8 the roof has no original timber in its construction. Bays 9 and 10 have C20th rafters and only the tie-beams and collars have been retained as a nod to the past. (See truss descriptions below).

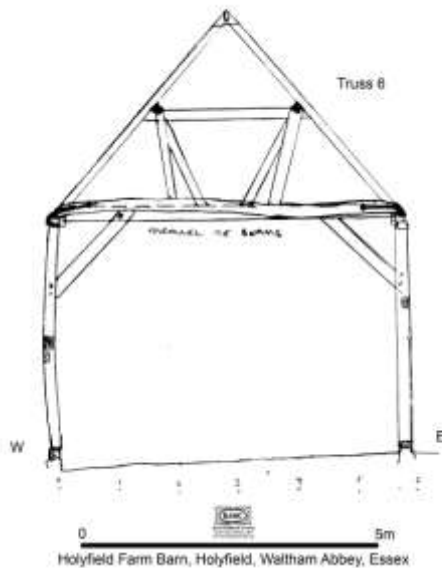
### Truss 6.

Truss 6 is almost entirely C20th with only the western principal post being retained. The old pole that served as a tie beam runs parallel with the new one and is held in place with C20th mild steel blacksmith's joints. The tie-beam is probably made of elm but it has been whitewashed so it may be any local timber. It does not resemble oak.

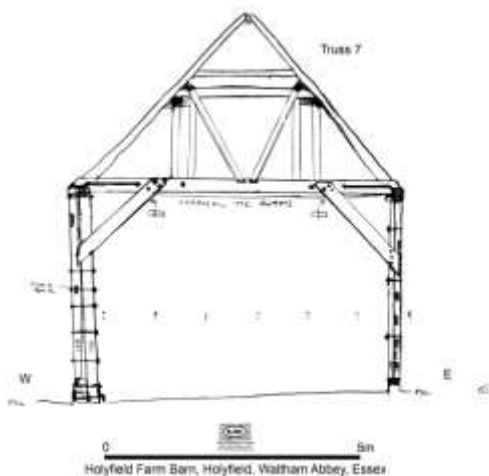
### Truss 7.

Truss 7 is almost entirely C20th with the principal posts being retained and bolted to new machined softwood ones. The old pole that served as a tie beam has been doubled up with a new one and is held in place with C20th mild steel blacksmith's joints. The tie-beam is probably made of elm but it has been whitewashed so it may be any local timber. It does not resemble oak. There are mortices in the underside for previous braces.

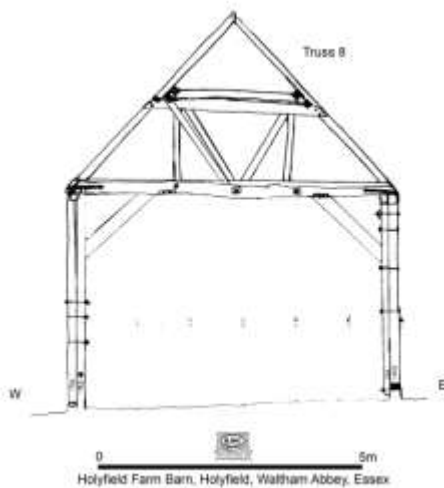
### Truss 8.

Truss 8 is almost entirely C20th with the principal posts being retained and bolted to new machined softwood ones. The old pole that served as a tie beam has been doubled up with a new one and is held in place with C20th mild steel blacksmith's joints. The tie-beam is probably made of elm but it has been whitewashed so it may be any local timber. It does not resemble oak. There are mortices in the underside for previous braces.

There are two old collars of which the lower is nailed in position rather than housed in the principal rafters. Two collars are required because in Bay 9 two purlins are carried across on the south side of the building. See following photograph.

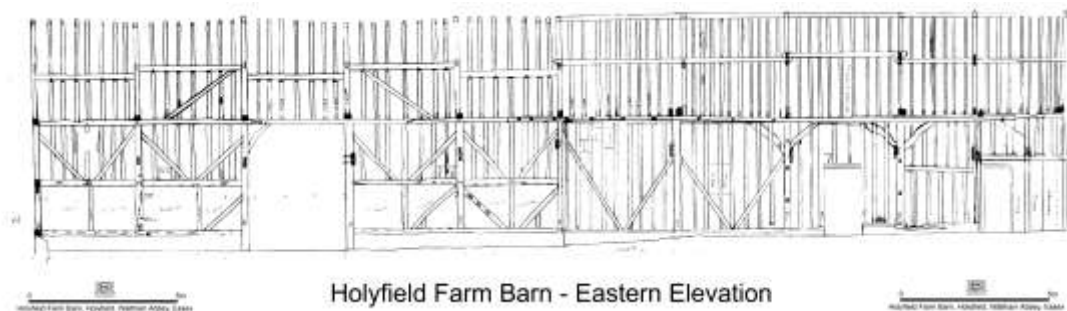
### The Eastern Elevation

The eastern elevation is the least complete due to its partial destruction by the blast from an explosion in the nearby gunpowder factory during the war in 1942. The walls in Bays 6 - 9 were completely replaced with a modern softwood construction consisting of V braced studwork panels in Bays 6 and 7 and a panel braced by a door frame in Bay 8. Bay 9 has also been replaced but the configuration incorporating a midrail has been retained.

On the principal posts to Trusses 7 and 8 are pairs of waney up-braces to the top-plate but these are now functionless as most of them have been severed to pass the studs through. They do indicate that this section of the barn had a different configuration to the rest and an original one is still in place in Bay 10. However these are not mimicked on the western elevation.

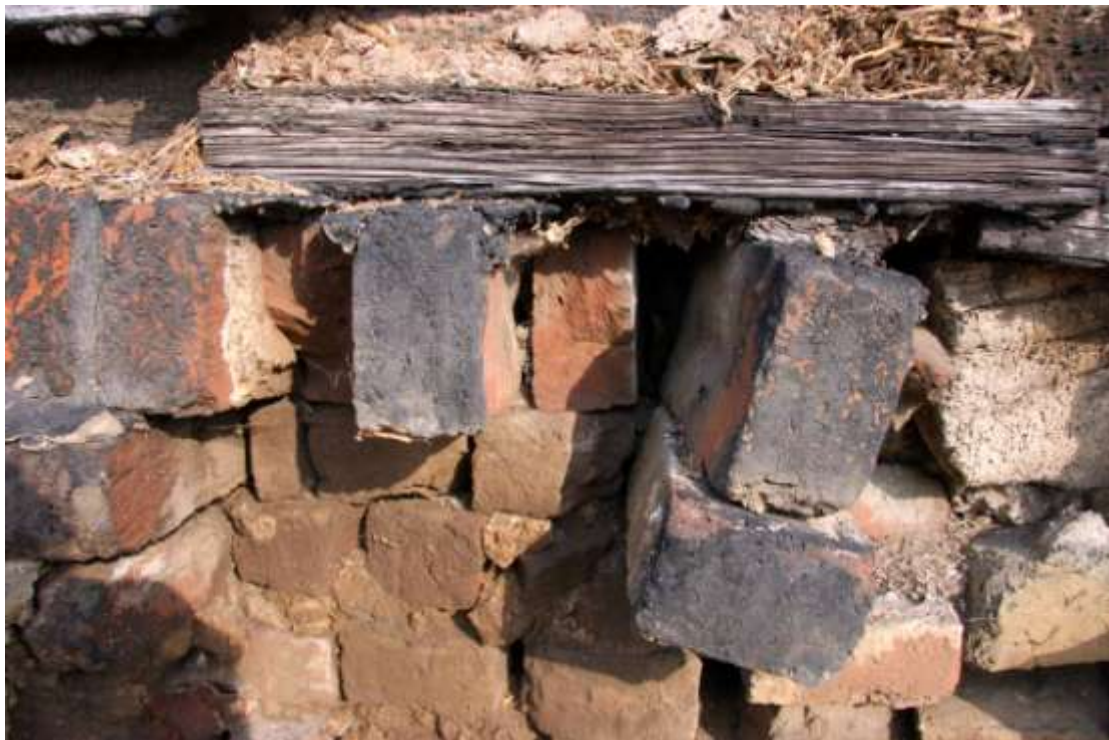
Where the plinth is ruptured frogged red bricks and London Stock yellows can be seen.

The plinth is composed mostly of red handmade bricks 65x110x220mm with creased faces, soft arrises and vertical pressure lines. They are set in a bed of lime mortar as mostly stretchers with a soldier course to rest the sole plate on. Where the plinth is ruptured on the western elevation it can be seen that many of the red bricks have shallow frogs and smooth bases.

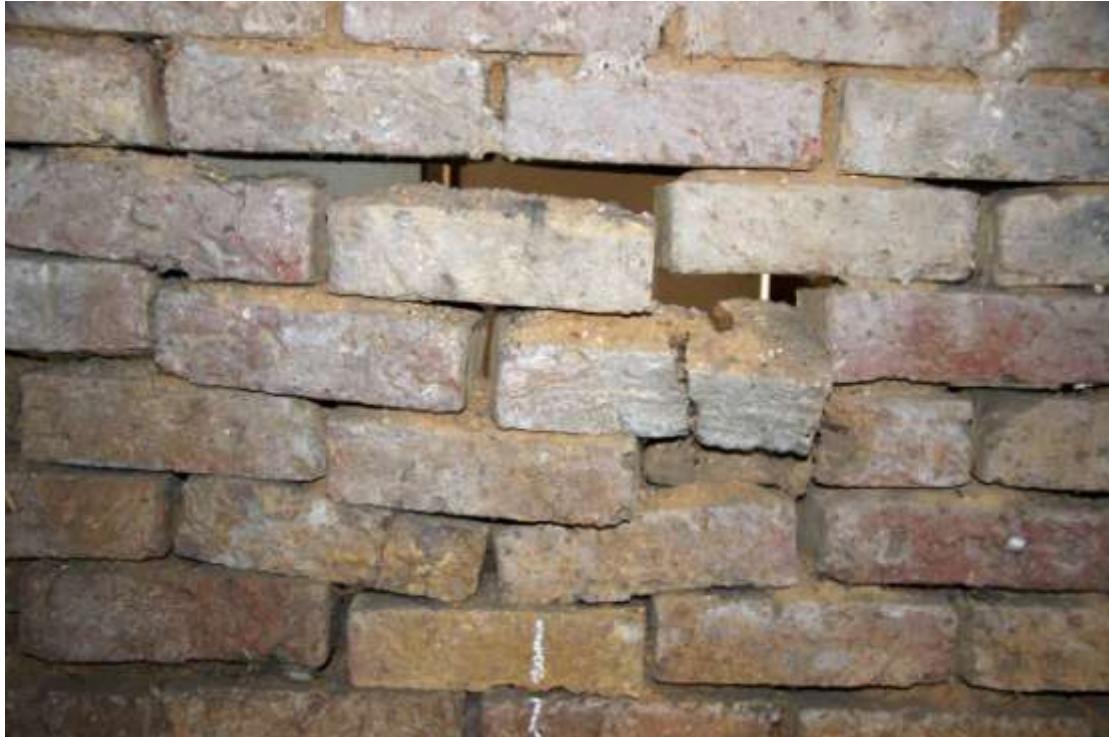
The failing pointing in the northern wall of the Cleaning Room.
