Suttons Manor, London Road, Stapleford Tawney Essex.
Description and analysis of a timber-framed summerhouse.
Surveyed 13 12 2010.

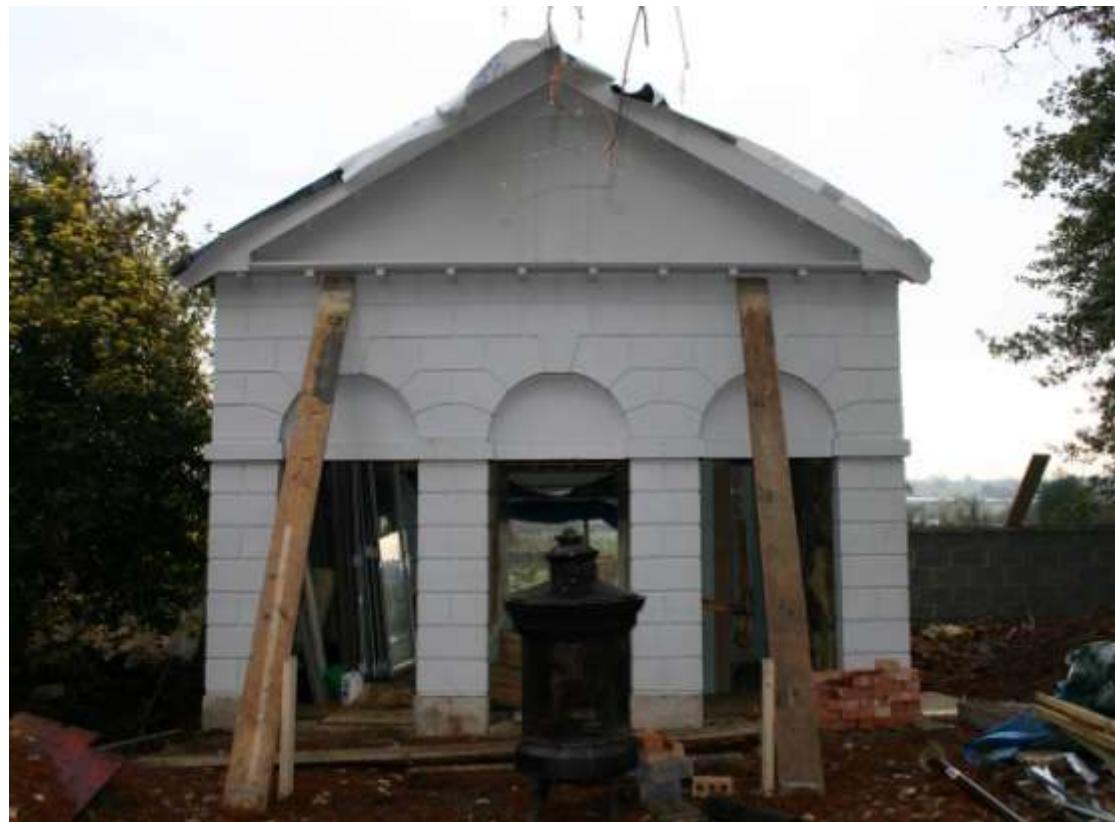
The northern elevation under restoration in December 2010.

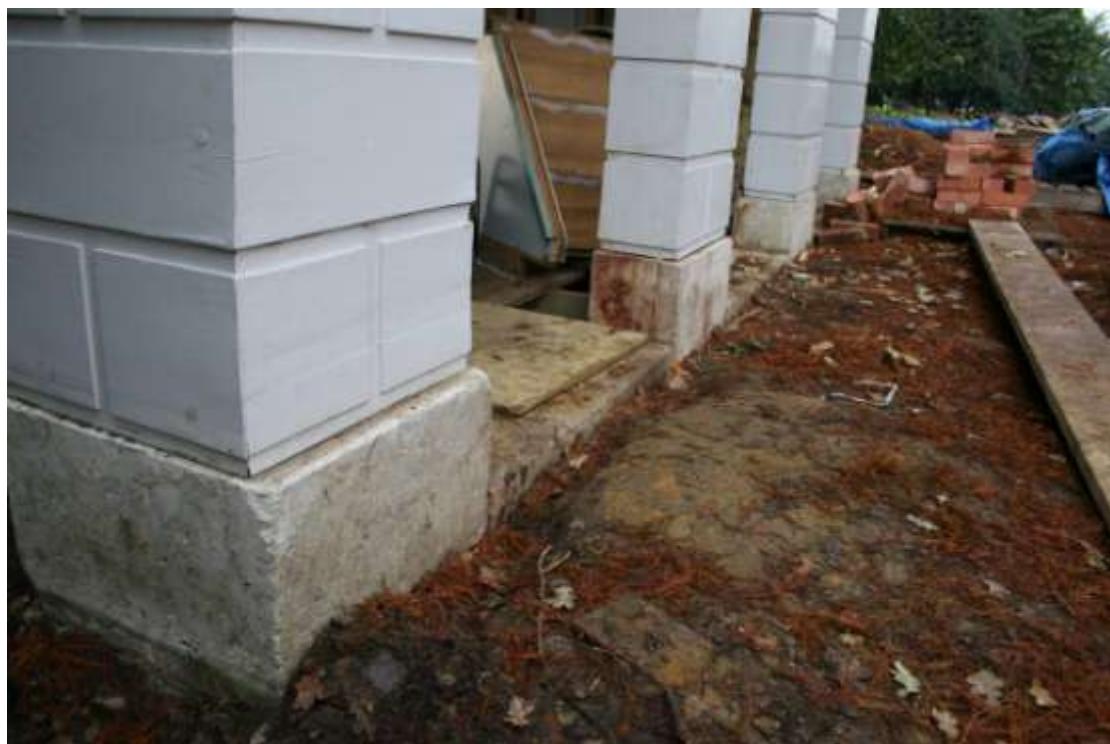
Original ashlar block pediments and stone door cills set on a brick plinth. Looking W.

The facade stands on ashlar stone blocks with stone thresholds to the openings which are all set on a buried red brick plinth which is visible in the flanks. The bricks are 60x110x235mm with creased faces, sharp arrises and no frogs or pressure lines. They are set in a thick bed of white lime mortar which has also been used to set the stones.

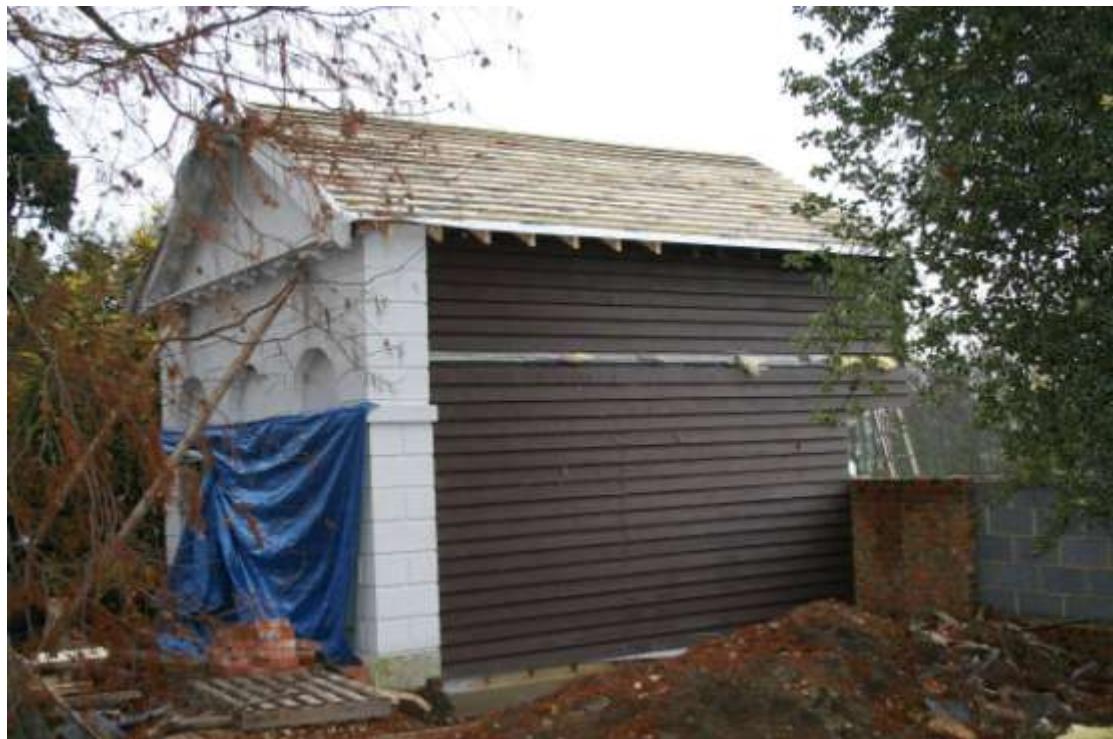
The western flank is entirely C21st built in 2009.

The western and eastern elevations are entirely modern and consist of 2009 machined softwood studs clad with feather-edged boards. The voids are filled with rockwool and sealed with a membrane. The rear of the building is jettied over the garden wall.

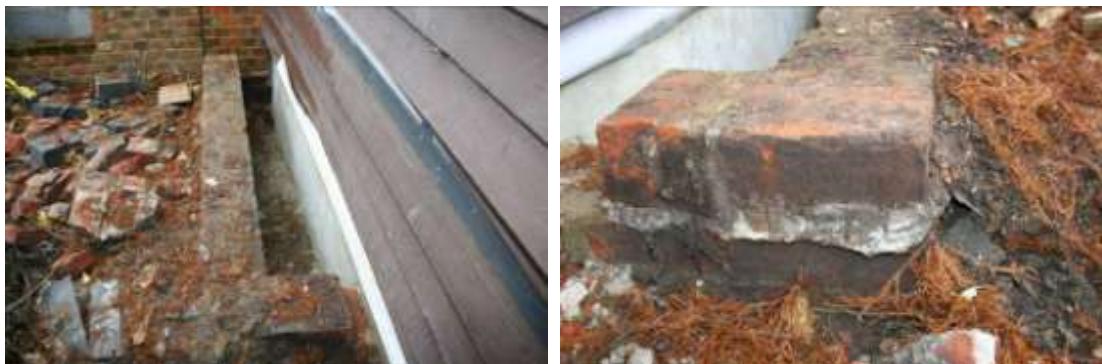
Brick plinths either side of the Summerhouse. Detail of the soldier course and white mortar.

Down each side of the building to the rear is a low plinth finished with a soldier course of the same bricks and mortar as the foundations. It runs parallel to the back of the building and then returns to meet the foundations approximately where the building steps down inside. It may be the back of the building was originally wider or that this is a revetment to keep the soil away from the timber walls descending to the garden.

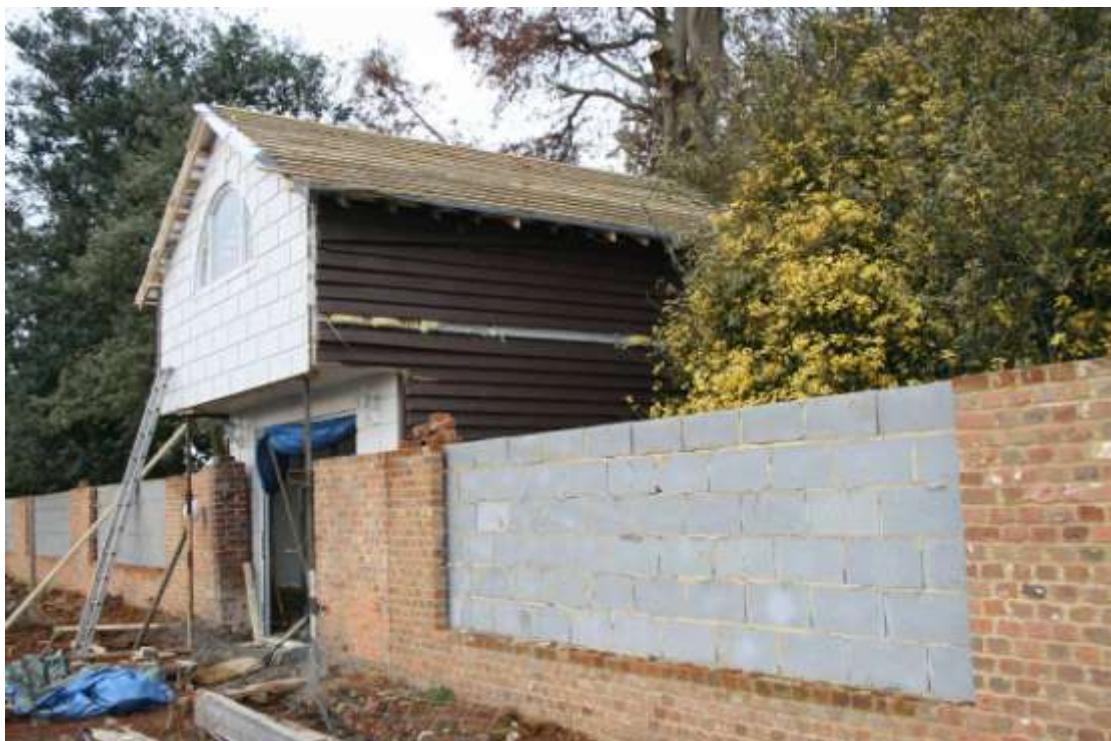
The eastern elevation is a reflection of the western one and entirely 2009.

The eastern elevation is entirely a reflection of the western flank and is largely screened by trees.

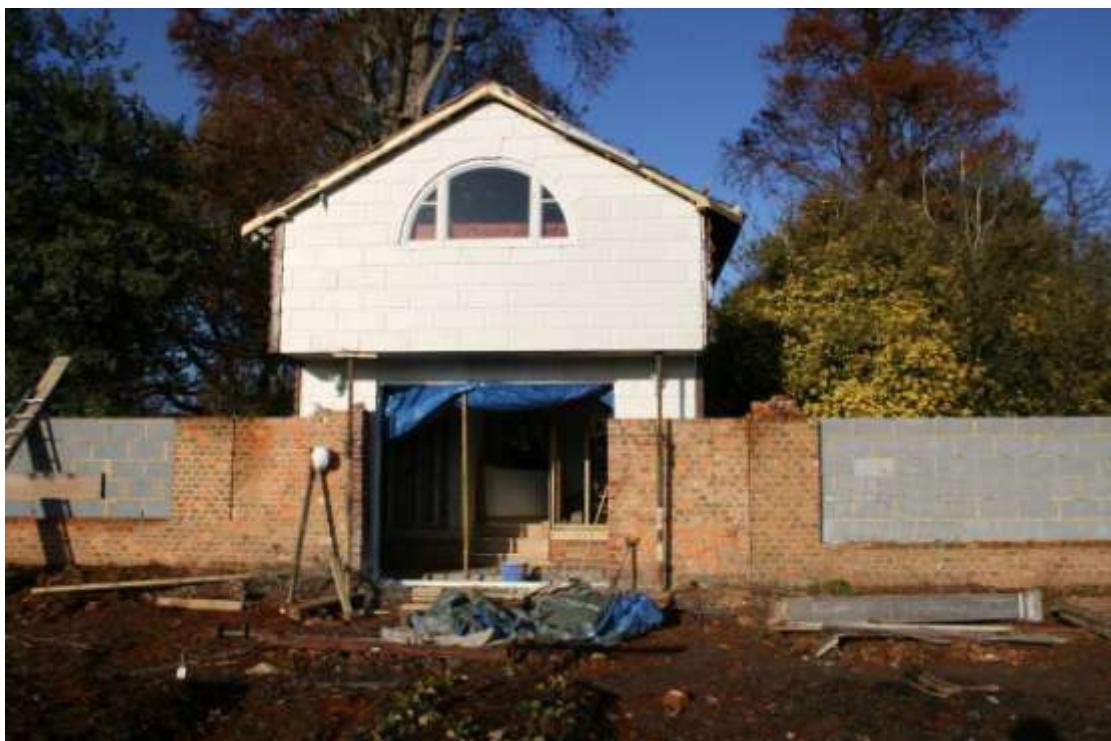
The southern elevation has a replica window and applied rustication.

The southern elevation is an entirely new construct reusing a replica window that photographic records show was made in September 1998. Very little was left of the rear of the building in November 1997 and it seems to have been rebuilt by the then owners.

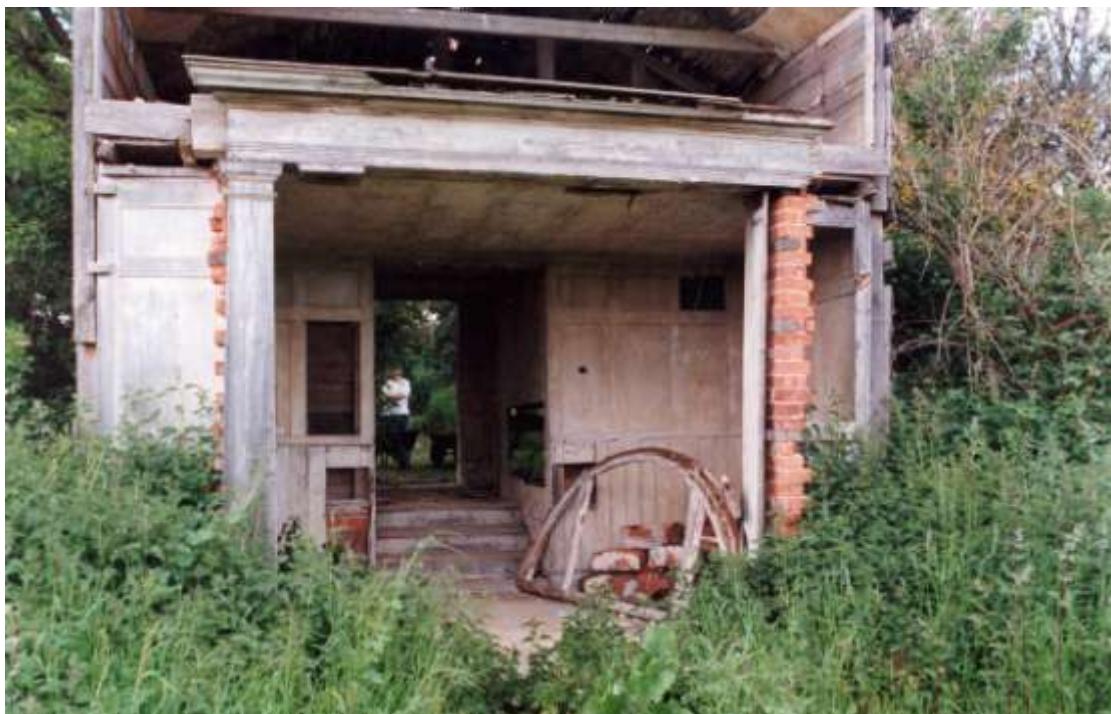
November 1997 showing the regency pilaster in-situ and the early basculating window.

The half round window has a central basculating large glass paned casement and there are two segmental side lights. A photograph taken in November 1997 shows the original window left in the back of the derelict building.

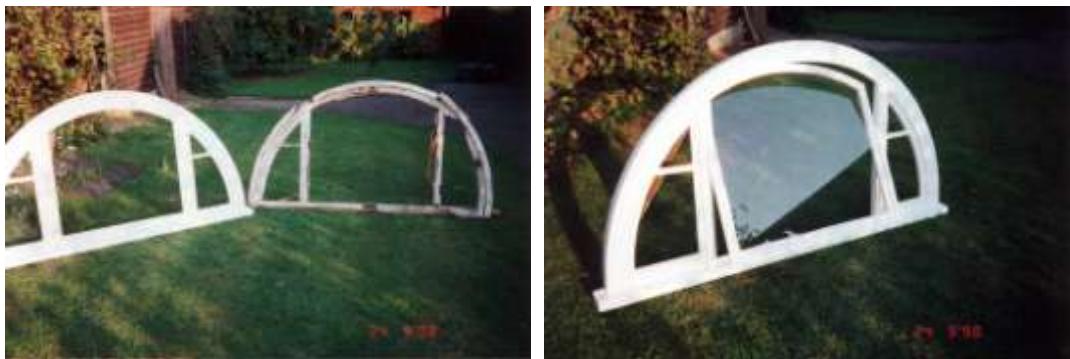
Replica basculating window photographed on 24/09/1998.

The half-round basculating window can also be ascribed to this period not least for its design features but also for the large pane of glass required for the tipping casement. The replica that is in place now appears to be faithful to the original shown in photographs.

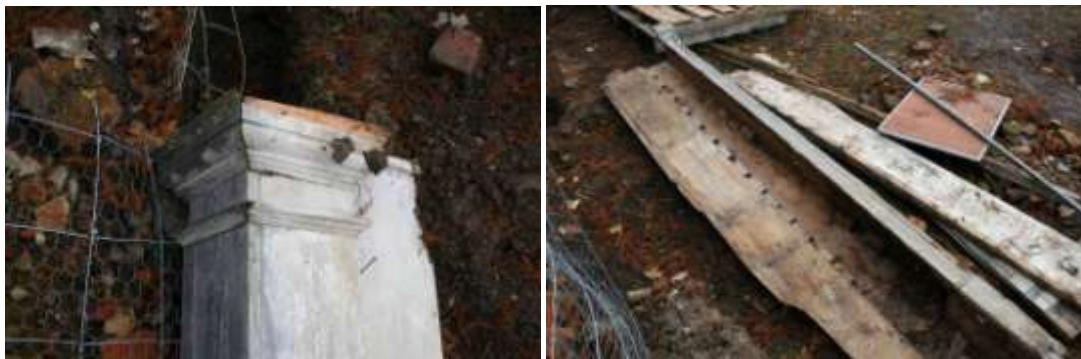
The capital of the regency style pilaster and the interior construction showing the fillets

The same photograph also shows that the building was set on two timber pilasters in regency style cladding the ends of the garden wall. One timber pilaster has been salvaged and was on the ground and the westernmost brick remnant has been built into the new wall.

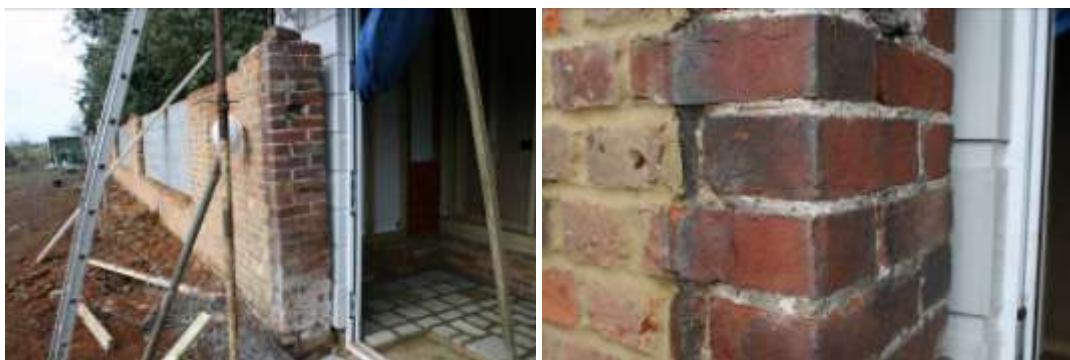
The brick remnant of the garden wall and detail of the penny struck pointing.

The bricks are a different colour and size to the rest from the garden wall. They are dark red/purples 65x105x225mm with smooth faces and sharp arrises. They are set in fine white mortar which has been penny struck. Four timber strakes are built in to receive nails from the timber pilasters.

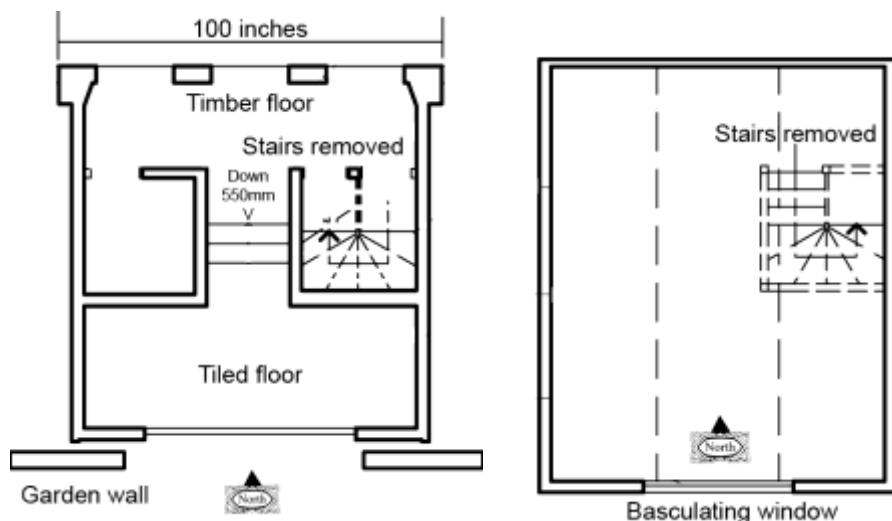
Plans made in 2009 by Ken Judge Associates. Stairs were removed during the survey.

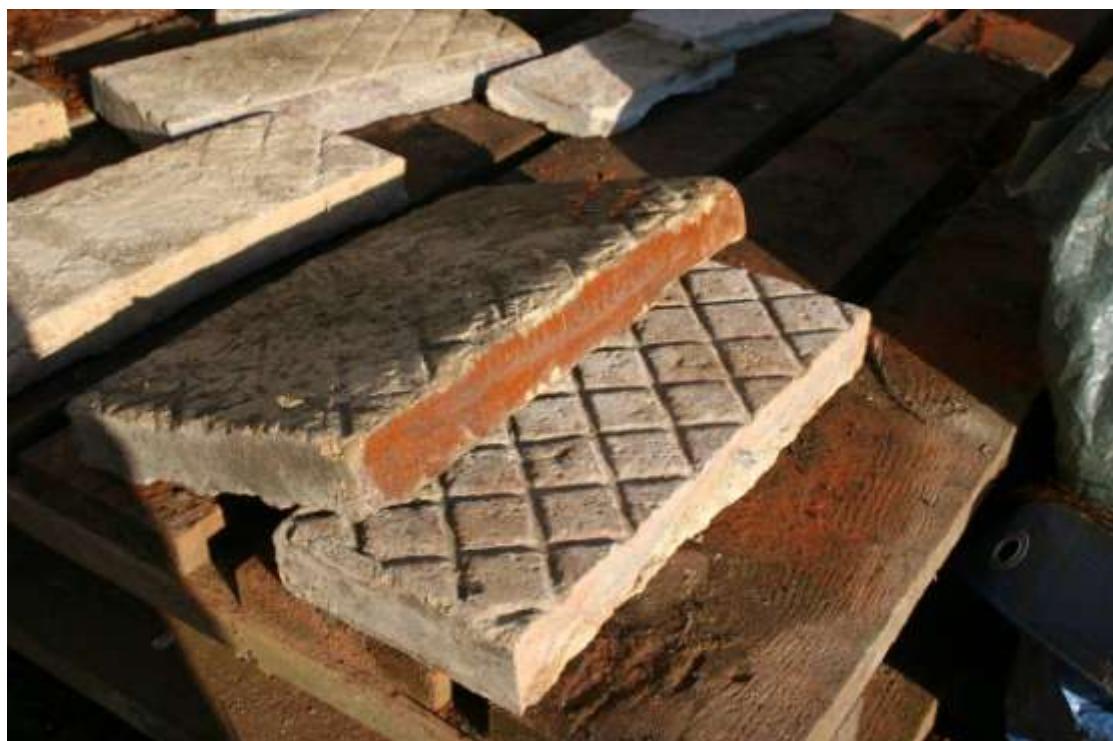
Doulton & Co ceramic floor tiles used in the rear of the building.

Apart from the rear of the facade none of the inside of the building is contemporary having been completely rebuilt in 2009. The floor drops 550mm from the front to the rear via three timber steps from a timber suspended floor to a paved area currently being finished with granite tiles and some earlier 12in textured tiles. These are ceramic and marked 'Doulton and Co' on the edges and probably date to c.1930.

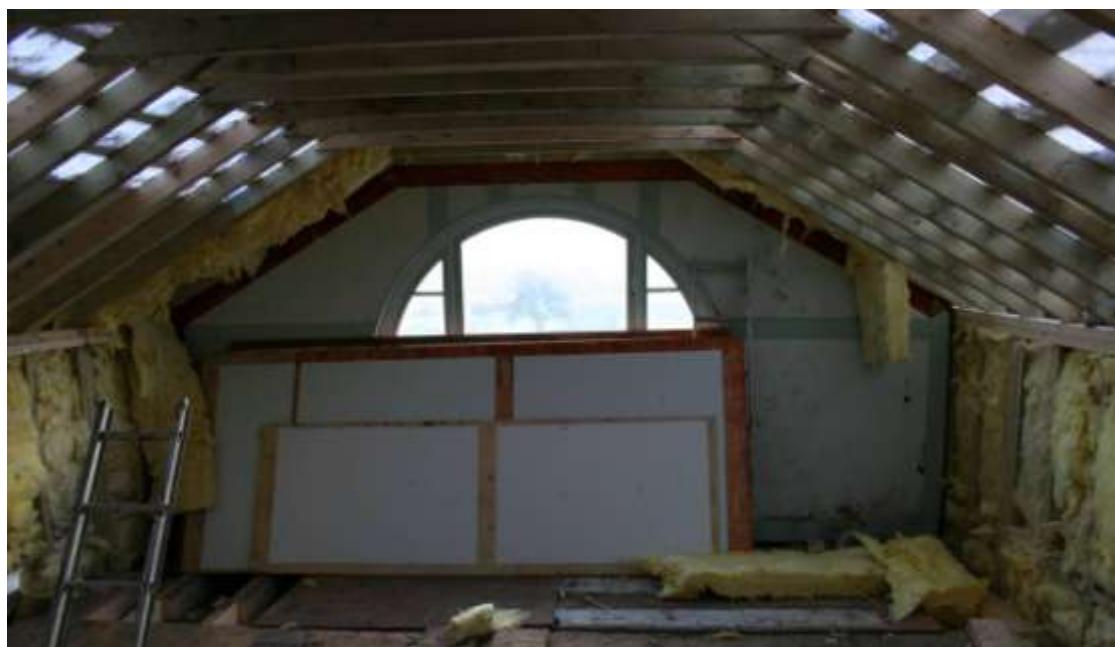
The upper floor and roof structure are all dated to 2009 and is a copy of the original below.

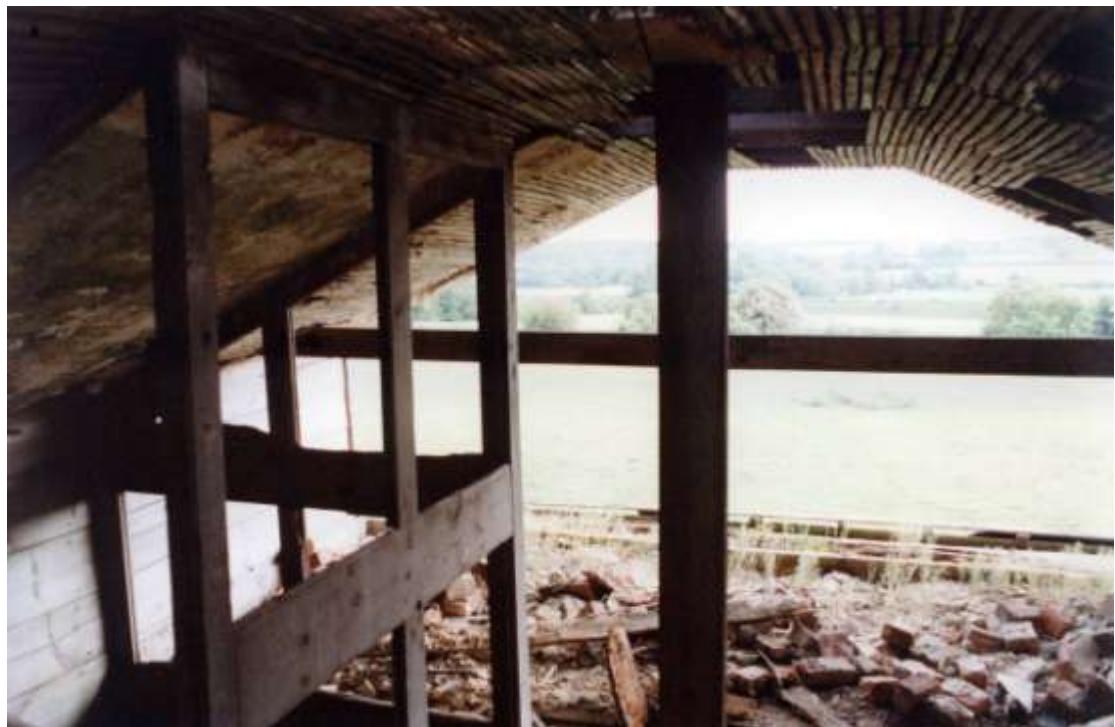
The upper floor photographed in November 1997. Roof propped with a plank. Note tie-beam.

The roof structure is a 2009 copy of the original with the exception that an eaves level tie-beam has been omitted. This may have been a later repair. The roof had been propped with a plank to prevent collapse. The paired rafters are collared at ceiling height.

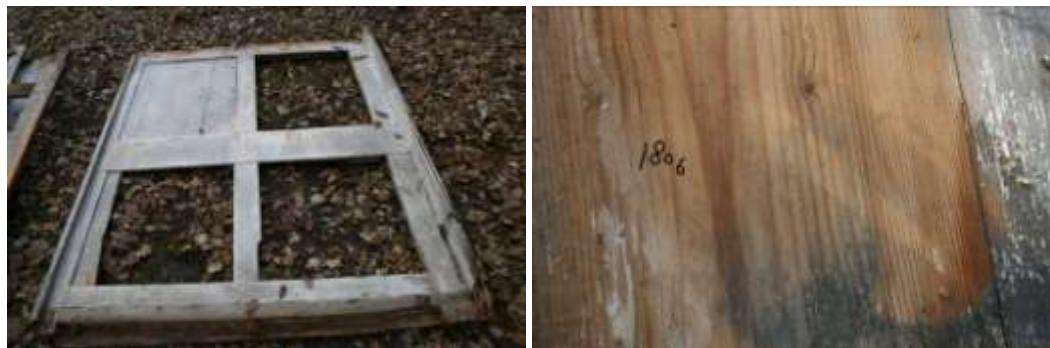
Original phase panelling with heavy section timbers dated 1806. (Overlined).

The earliest has heavy section stiles, transoms and muntins 2ins thick with a 1in rebate to take heavy panels faceted on the rear to fit. The outer faces are painted stone grey with distemper which rubs off easily and an oil based paint. Most of the panels are missing but there is one marked JAMES in a 1970's typeface on the back. Below this there are two pencilled signatures or sentences which were unreadable due to the wetness of the timber but they did not appear to be in English. The date 1806 is also written below these.

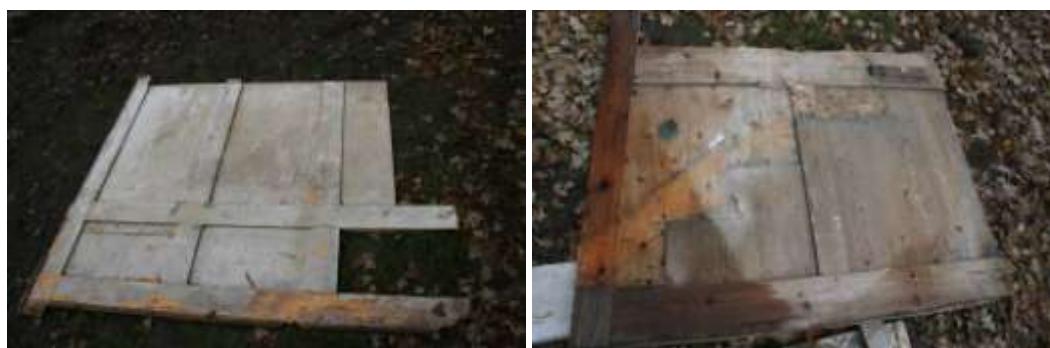
Second phase panelling from inserted staircase.

The second set of panelling is associated with an inserted staircase made of thinner 1.25in machined softwood and planed boards. The remains of the lower part of the staircase was also retained although it is beyond reuse. There is an important distinction in the types of nails used to fasten these components together.

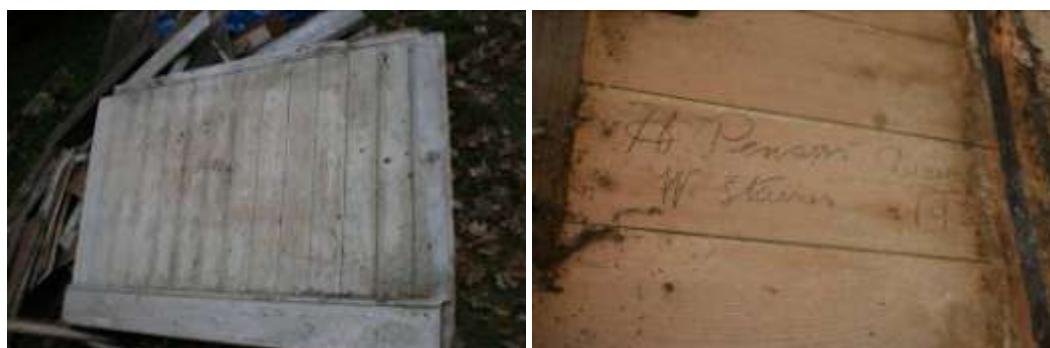
Third phase wainscoting dated 1930 and signed.

The third phase of panelling in the form of wainscoting was made in December 1930 by H Pewson and W Staines who were kind enough to write it clearly in pencil on the back.

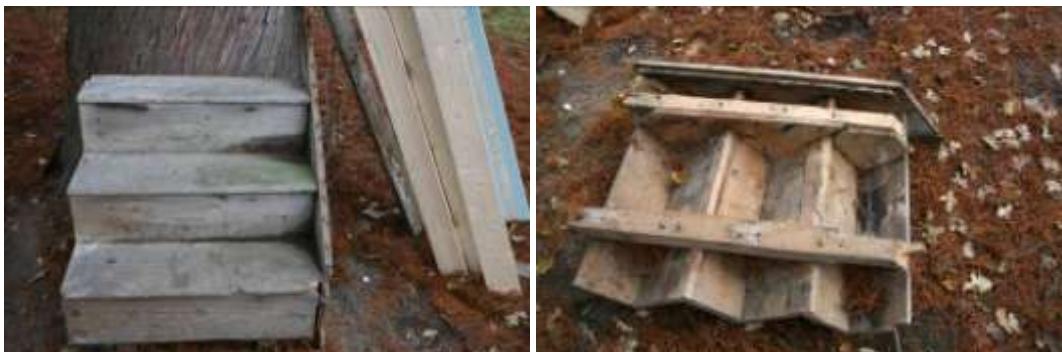
Lower section of the inserted staircase.

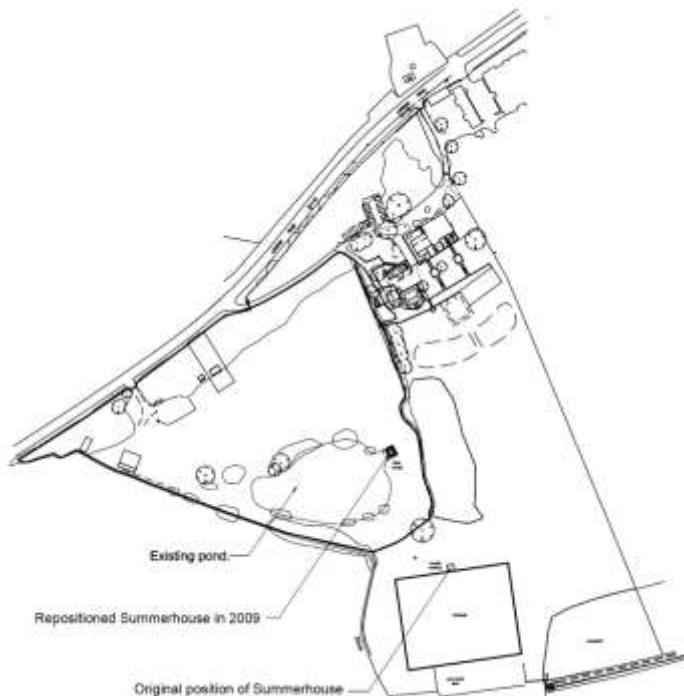
2009 Repositioning of the Summerhouse to the lake. Ken Judge Associates.

In 2009 the Summerhouse was dismantled and re-erected by the Burrows Lake. Only the timber facade was used and the other old timbers were retained. In 2010 the building was lifted by crane and returned to its original position on the same footings.

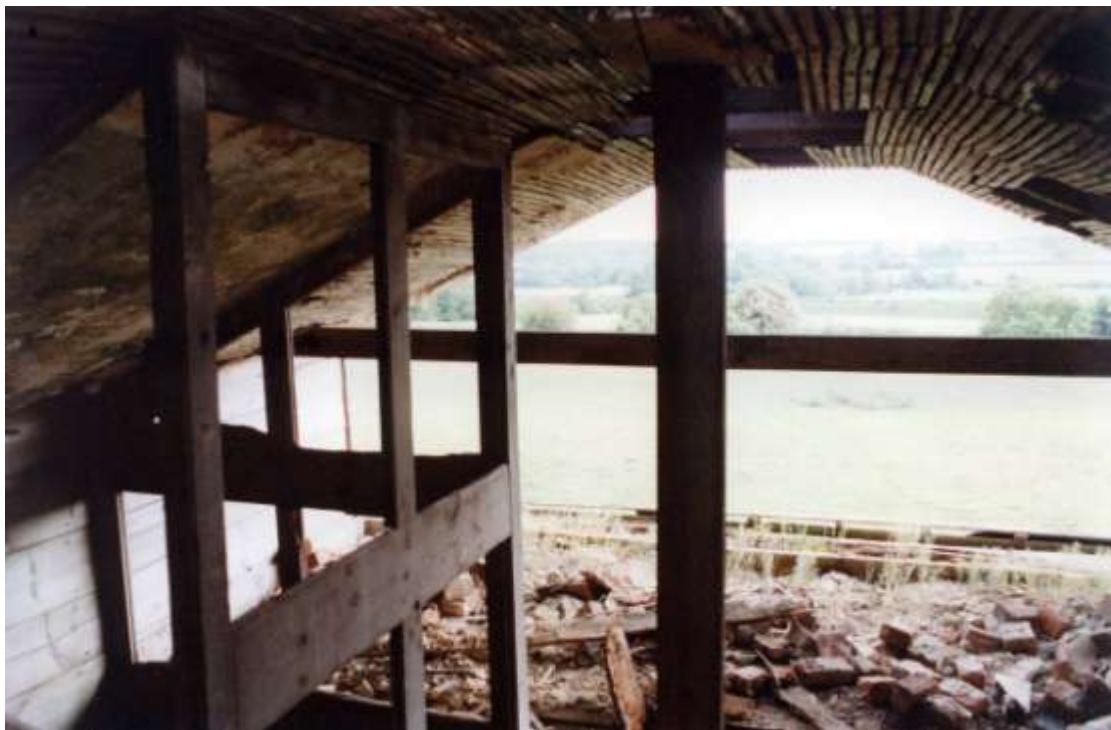
1997 Summerhouse upper floor looking south.

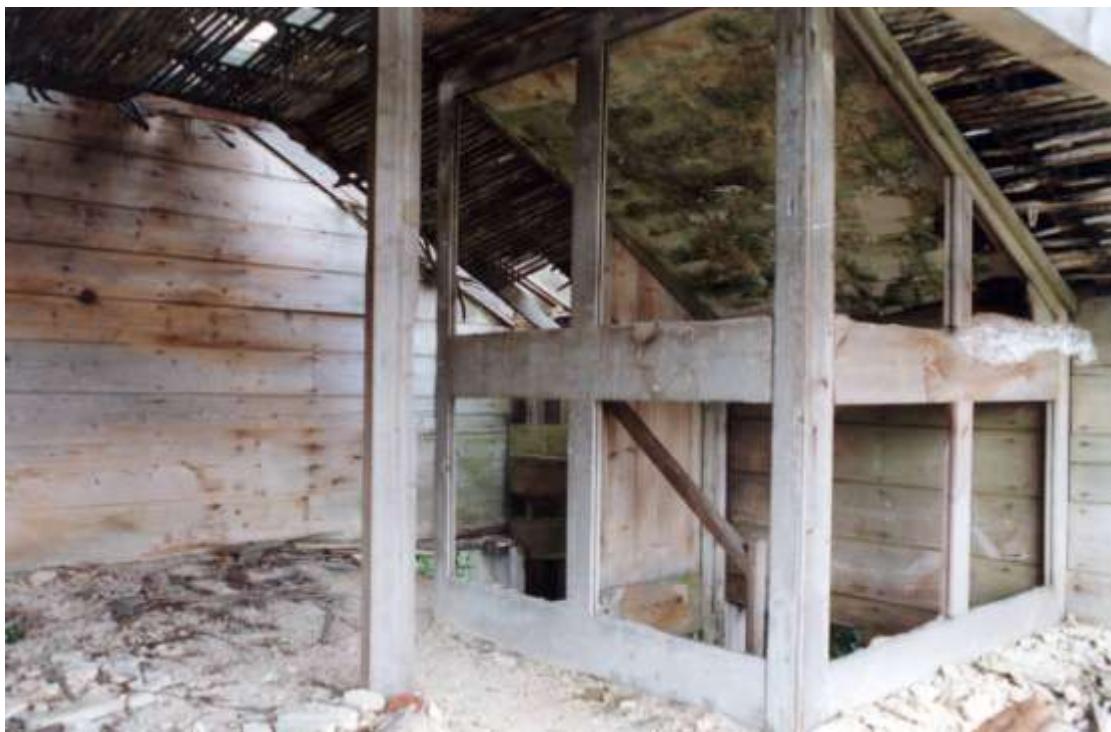
1997 Summerhouse upper floor looking NE at the staircase. Note door in the side wall.

The staircase is made of machined timbers and fastened with Type B cut clasp nails which were not available until 1810. The thin sections and finely routed mortices indicate a construction date later in the Victorian period. Photographs taken in 1997 indicate there was a side door for access to the stairwell and the first floor walls were horizontally boarded.

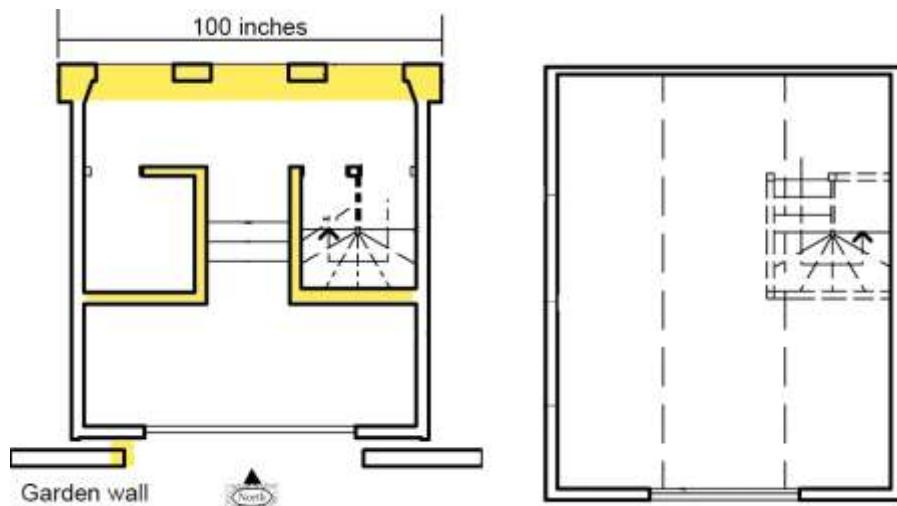
Phase 1. 1806?

The Italianate style of the facade with its romanesque arches and rustication was very popular in the Georgian period (1714-1838). The fabric, the methods of construction using glued fillets and wrought iron pointed nails are consistent with this period.

There is a pencilled in date of 1806 together with some undecipherable writing on the back of the internal panels which strongly indicate that this is when the Summerhouse was erected. The previously built garden wall was altered with later, darker coloured and different sized bricks used to finish the opening and the pointing penny struck. Timber strakes were incorporated in the terminals to nail two Regency style plain pilasters to support the rear of the building.

The bricks used in the foundations and the flanking revetment plinths are also typical of this era. The 12x24in grey roof slates were commonplace and were used universally to clad all kinds of buildings. Most of the lower facade is original and some of the internal panels that have been saved are too.

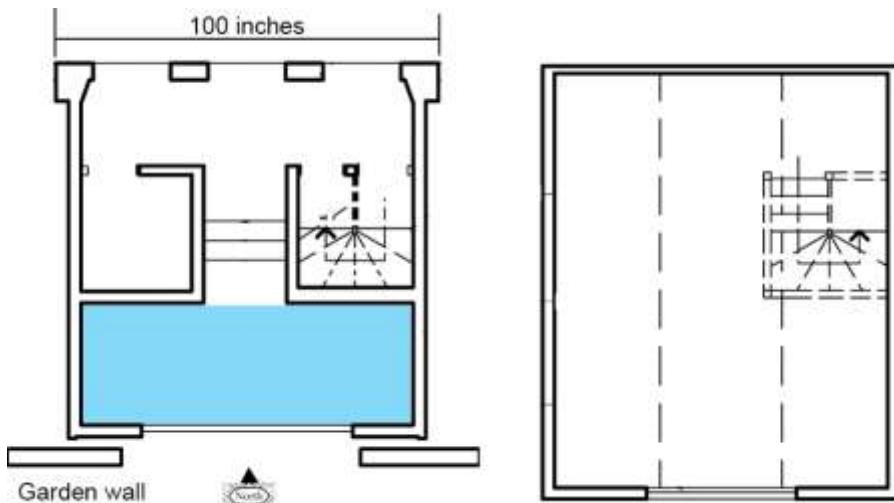
Phase 3. 1930.

In December 1930 H Pewsey and W Staines constructed wainscoting for the rear of the building. It is also likely that the Doulton & Co floor tiles were laid at the same time.
