## Description and Analysis of the Fabric of the Barn at Holyfield Farm, Holyfield, Waltham Abbey, Essex. 20th March 2009.

### **General Description.**

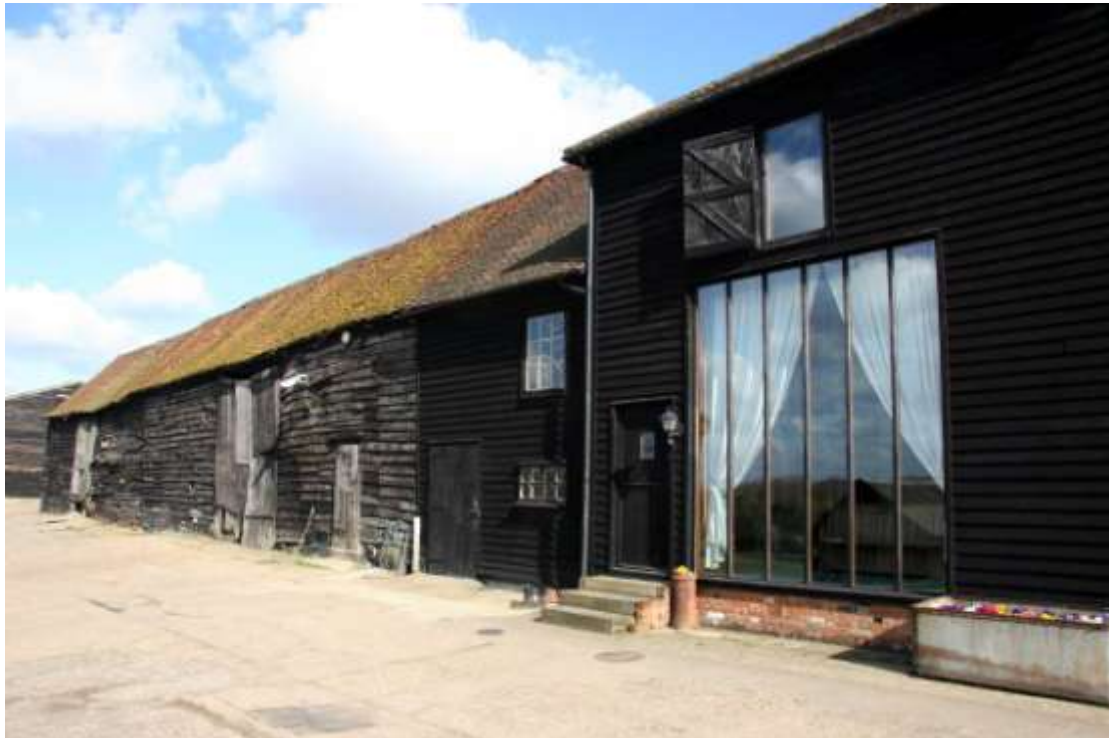
Western elevation from the SW. The barn is annexed to the current farmhouse denoted by the black weatherboarding.

There are two large barns doors, both of C20th construction being nailed vertical softwood plain edge board with a variety of vernacular repairs. The ledgers and braces show clear marks of a circular saw. The long strap hinges are secured with modern fixings. Both are in poor condition and unable to be opened fully.

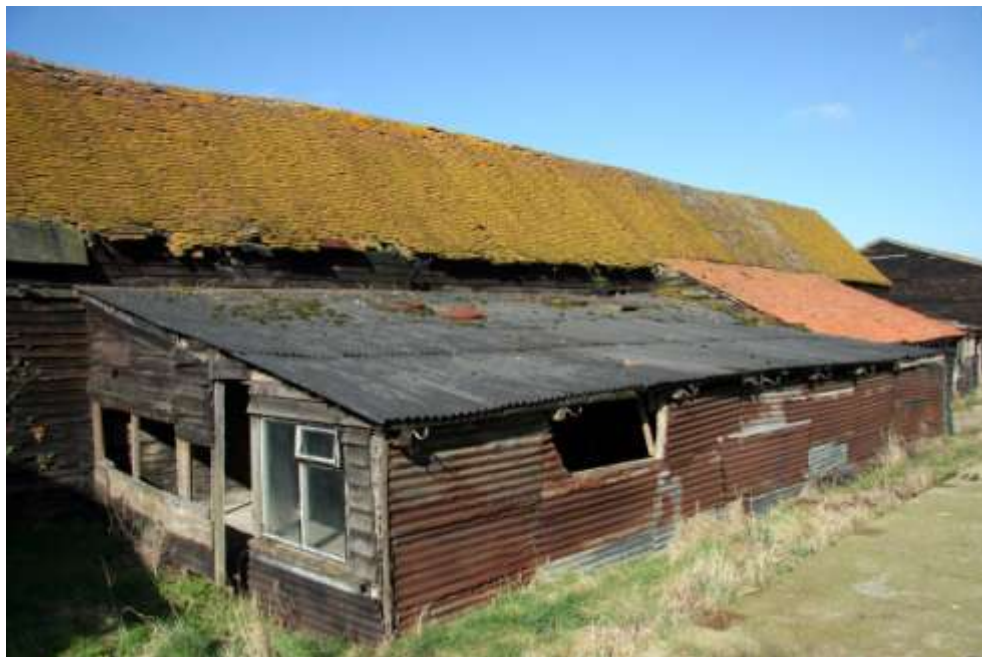
The Chicken House on the eastern elevation of the barn.

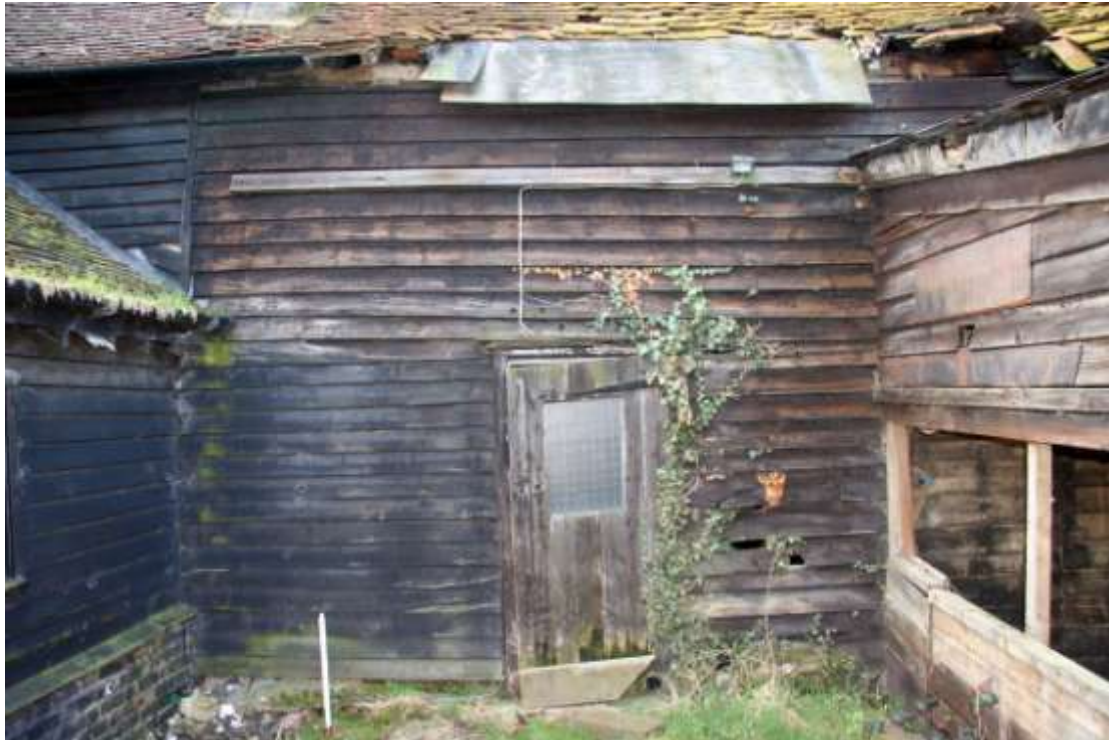
The section of weatherboarding that forms the cladding to the Cleaning Room is C20th in construction. The boards are machined softwood held in place with galvanised french nails. The boards have been coated in hot brushing tar which has largely peeled off. The door is very similar to that on the western elevation except that it retains its glass panel. It is C20th in design and construction.

The back door to the Cleaning Room. Weatherboarding and door are C20th.

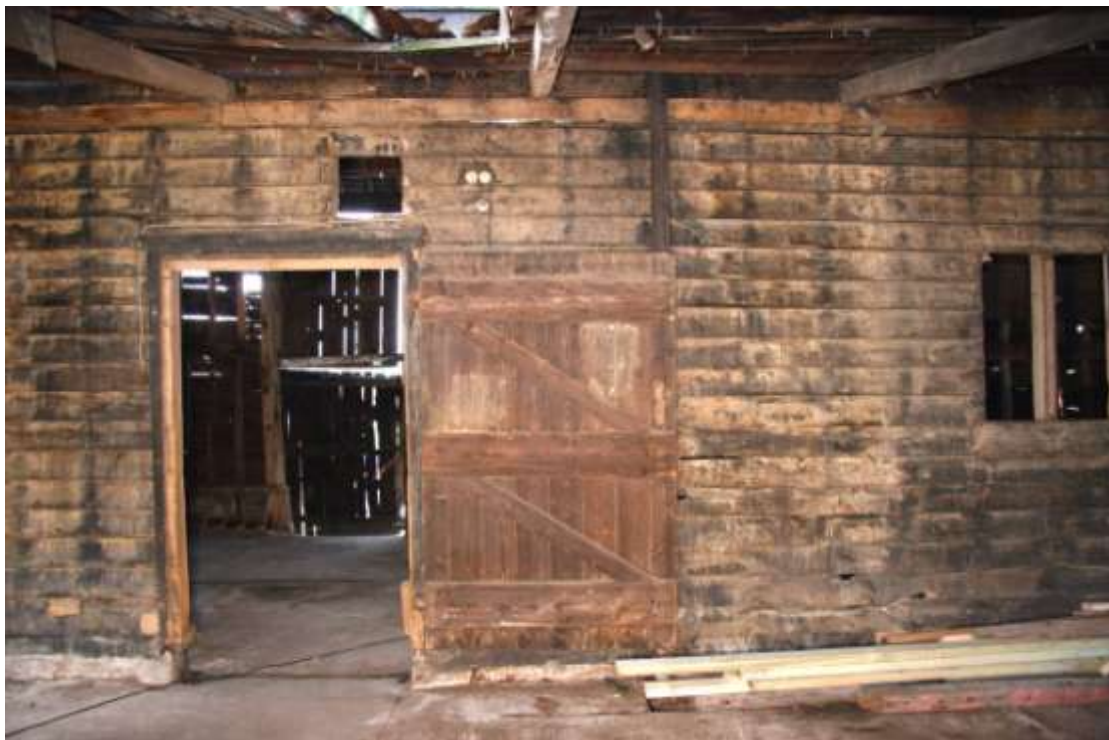
The eastern elevation of the barn inside the Chicken House. C20th door and unframed window.

The hot tarred boards continue into the Chicken House to the north where they clad Bays 6 - 9. This section is entirely C20th and is part of a wholesale replacement of the eastern wall as a result of damage made by an explosion in 1942 in the Waltham Abbey Royal Gunpowder Mills.

There is a substantial vertical boarded, softwood gate and ledger door where the battens are clenched with wrought iron nails and so are the long pintle strap hinges. However it is in very good condition and sits in a c.1942 doorframe. It is more likely of this period than earlier as its rate of wear is the same as the weatherboarding.

There is an unframed opening into the barn in Bay 7 and a small unframed opening above the door. There are also 3 unframed openings in Bay 6 but two of these pass above the roofline of the Chicken Shed and may have been enlarged due to water damage. These smaller openings were to allow the chickens access to the barn.

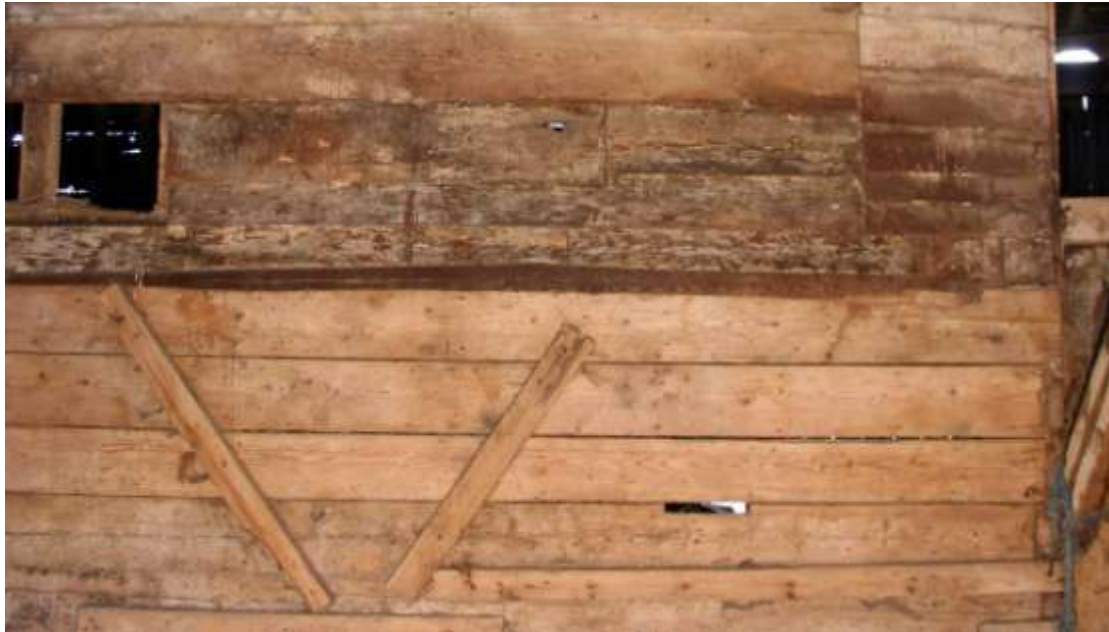
Manger support rails are nailed to the floorboards applied by Mr Chapman senior.

There are two battens on the barn wall aligned in a V shape which denote the former presence of a manger. The current weatherboarding below the midrail on the barn itself is of reused floorboards and placed there by Mr Chapman senior. The boarding above is an eclectic mixture of wide and narrow section boards fastened with wrought iron nails, none of which have ever been tarred implying the Central Outshot has always been there in some form.

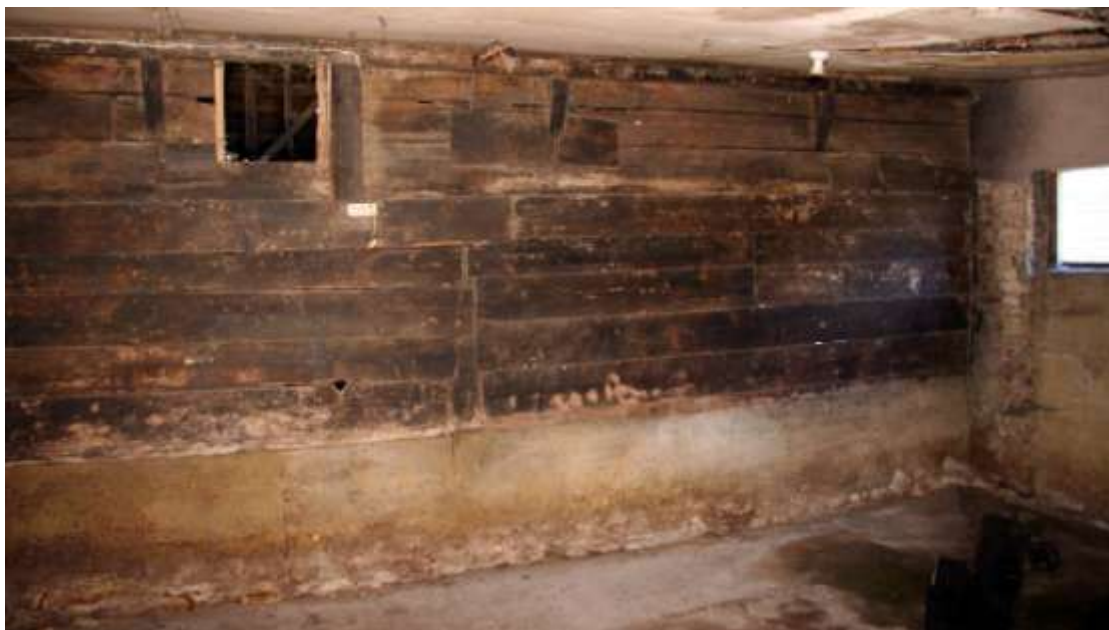
The weather boarding is made of reused floorboards put in in the C20th.

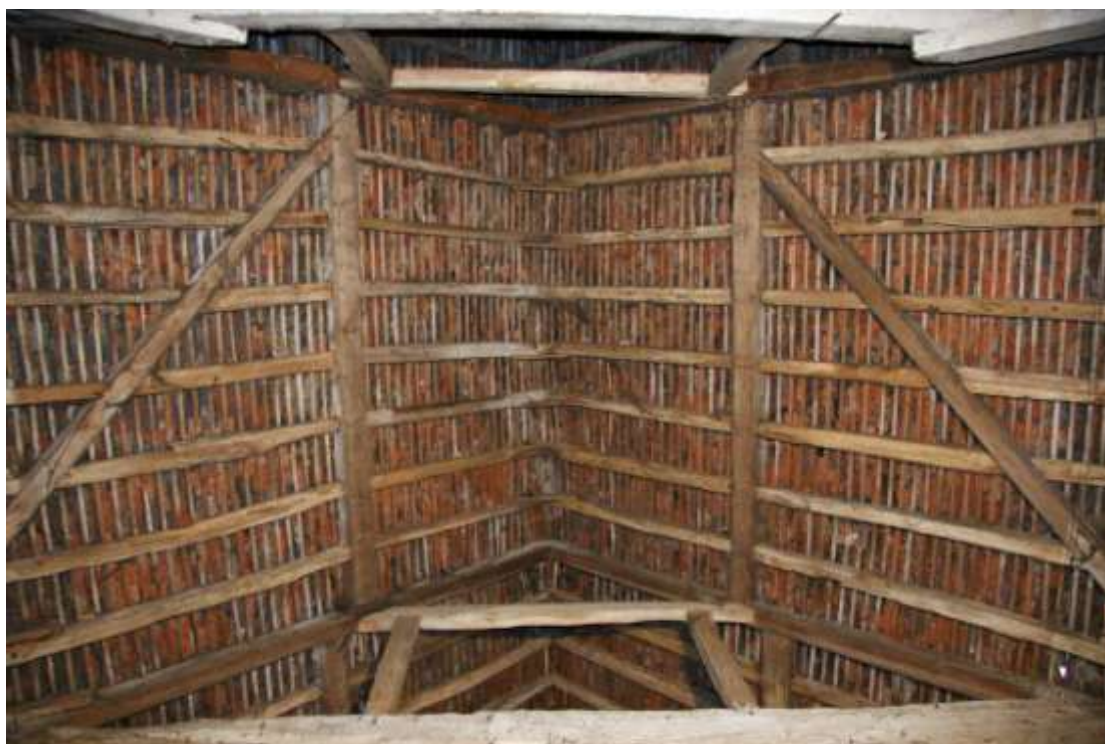
The roof structure is most clearly shown in Bay 4. Note the wind-braces housed in the purlins and the cut and nailed rafters. Looking south. Several rafters are reused or turned over.

The roof structure in Bays 1 -5 is that of an offset butt purlin roof where the principal rafters are connected near the mid point above the top-plates by an axial beam housed in the faces of the principal rafters. The line of the purlin is not continuous but offset by the width of the purlin between each bay. The rafters are then tenoned top and bottom into the purlins.

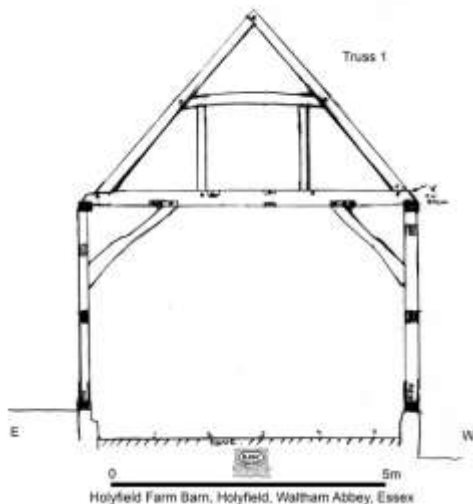
### Truss 1.

The tie-beam is re-used from an earlier structure and the over-sized mortices of the original braces are present in the underside. In the upper face there are a number of mortices which do not correspond with the upper assembly. The tie-beam braces are halved from a single tree.

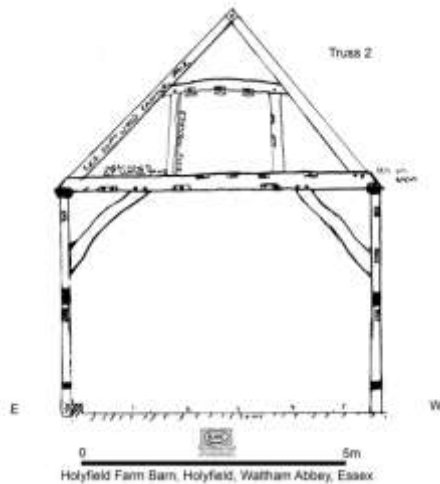
## Truss 2.

In Truss 2 the principal rafters are red softwood and the pine knots are quite clear in them. The tie beam is cut down from a much longer timber and the vacant mortices of the original braces are present in the underside. In the upper face there are a number of mortices which do not correspond with the upper assembly. Both the queen struts are of reused timber, one being edge moulded. The collar is reused from another timber and the mortices on its underside are round ended illustrating the style of carpentry common from the early 1800's where the builder (rather than carpenter) couldn't be bothered with squaring off the mortice. The tie-beam braces are halved from a single tree.

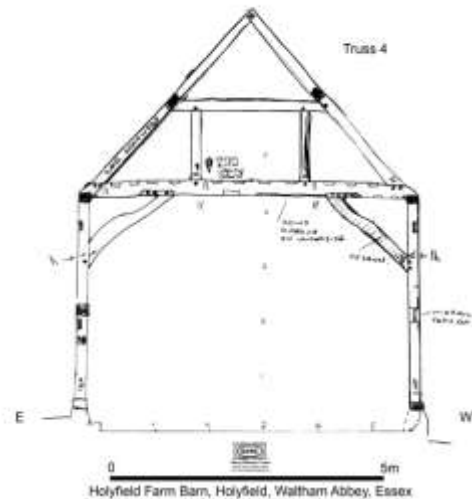
#### Truss 4.

The tie-beam is re-used from an earlier structure and the vacant mortices of the original braces are present in the underside. In the upper face there are a number of mortices which do not correspond with the upper assembly. There is a long groove carved in the underside. The waney tie-beam braces are not halved from a single tree but are separate elements.

The queen posts are reused timber with the easternmost one having an upside down taper burn mark on it.

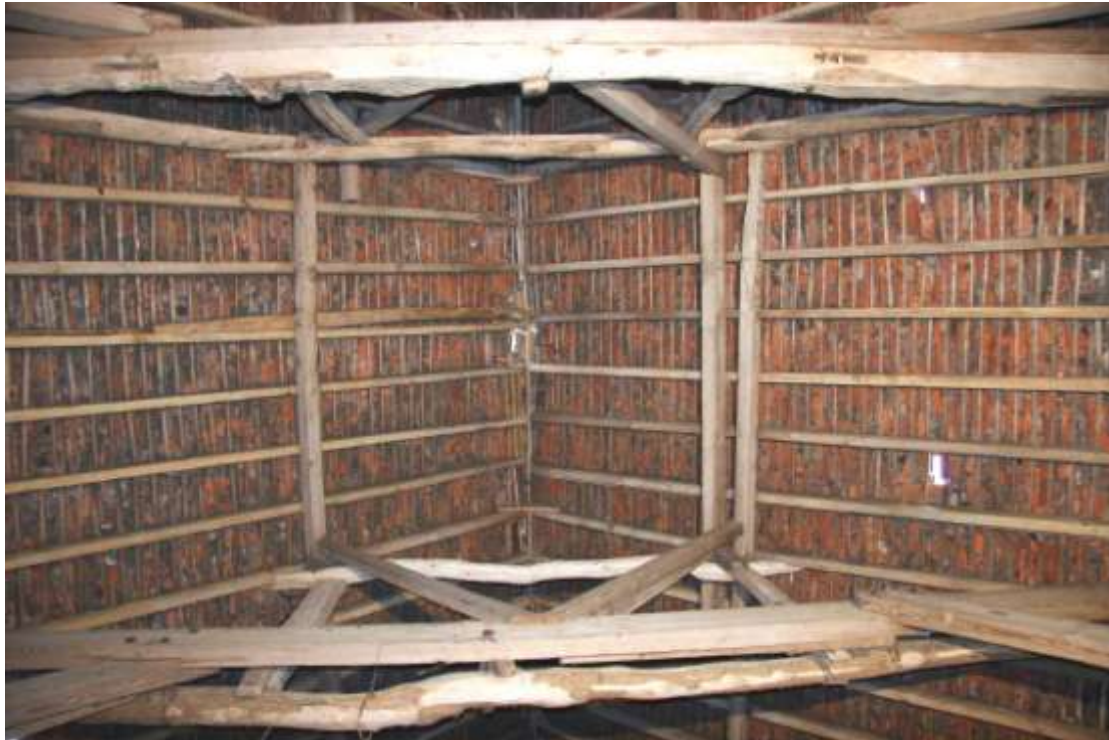
Truss 8 is almost entirely C20th with the principal posts being retained and bolted to new machined softwood ones. The old pole that served as a tie beam has been doubled up with a new one and is held in place with C20th mild steel blacksmith's joints. The tie-beam is probably made of elm but it has been whitewashed so it may be any local timber. It does not resemble oak. There are mortices in the underside for previous braces.

There are two old collars of which the lower is nailed in position rather than housed in the principal rafters. Two collars are required because in Bay 9 two purlins are carried across on the south side of the building. See following photograph.

Bay 9 looking south showing trusses 8 and 9. Note the double purlin to the western side and the old poles doubled up with C20th timber.

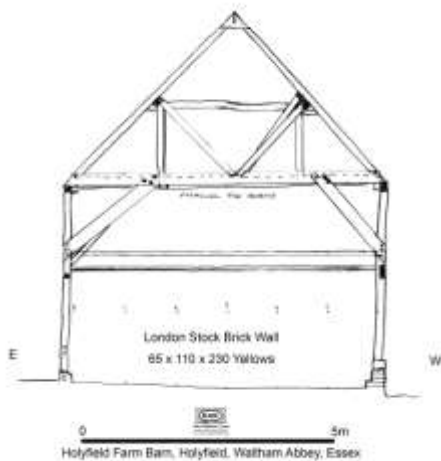
### Truss 9.

Truss 9 is built flush up against the London Stock brick wall forming the Cleaning Room in Bay 10. The principal posts are quite slight in comparison to all the others at only 140mm thick. Like the previous trusses the whole assembly has been rebuilt with machined softwood and a waney pole placed in parallel with the new main tie beam. The collar is also a waney pole which seems chosen because it fits in with the double purlin arrangement on the west side of the building. Neither of these poles have signs of reuse in the form of vacant mortices and were probably placed there at the same time as the modern timber.

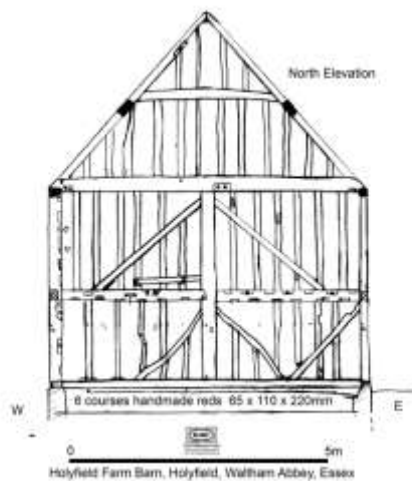
#### North Wall

The northern elevation sets the pattern for the construction of the walls of the entire barn and the form is repeated throughout except where the barn has been remodelled in the C20th.

The principal posts are connected by a top-plate, acting also in this elevation as the main tie-beam. A central post supports the top-plate at its mid point and then carries substantial mid-rails. The frame is braced above the midrails by single diagonal struts from the midrail to the central post. Below the midrails, the central and principal posts are braced against the sole plate with V-braces (the far western one is missing and the studs are replacements).

The midrails have very many redundant mortices on both sides which either indicates that the timbers have been turned over or that the building was double skinned at some point. The western midrail is actually nailed onto the centre post rather than housed. Several of the midrails have mortices cut horizontally into their faces which are angled for braces and it is evident that they were previously used in an upright position.

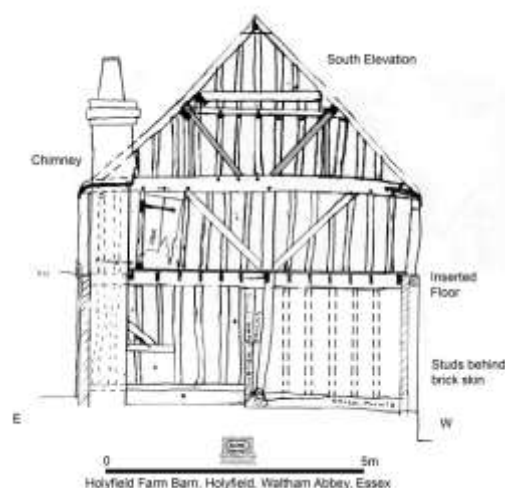
### The Southern Elevation

In essence the southern elevation is a reflection of the northern one. It differs in having been highly modified since its original inception. The lower part of the frame below the rail has been rebuilt in brick. To the east of the centre post the panels between the studs have been infilled with brick noggin whilst to the west a brick skin has been built inside the timber one.

The diagonal braces and the studs connected to them are fastened with wrought iron nails. There is a single carpenter's mark, number IIII, visible on the eastern end of the tie-beam on the southern side. A small two plank door has been inserted by removing a stud. It is hung on a thin wrought T-strap at the top and a now missing pintle strap at the bottom. The pintle is in place in the frame.

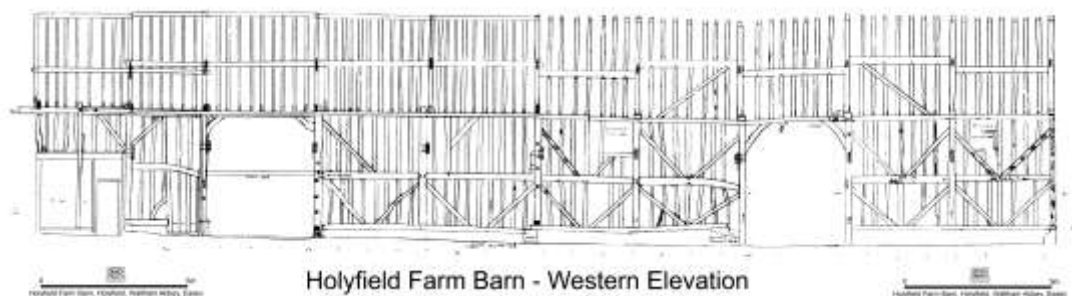
### The Western Elevation

The western elevation is more complete in its form and the V bracing above and below the midrail is consistent throughout most of its length. However the upper sections in Bays 6 and 7 have been rebuilt with some modern softwood insertions and three of the V braces lost. These bays correspond with the replaced ones in the eastern elevation and were probably remodelled as part of that exercise.

Again there is much reused timber in the construction of the elevation especially in Bays 1 and 2 where the midrails and the diagonal braces and several of the studs have redundant mortices. One diagonal brace in Bay 1 is clearly from a top plate of a much older building and has the indents for 'scotched rafter feet'.

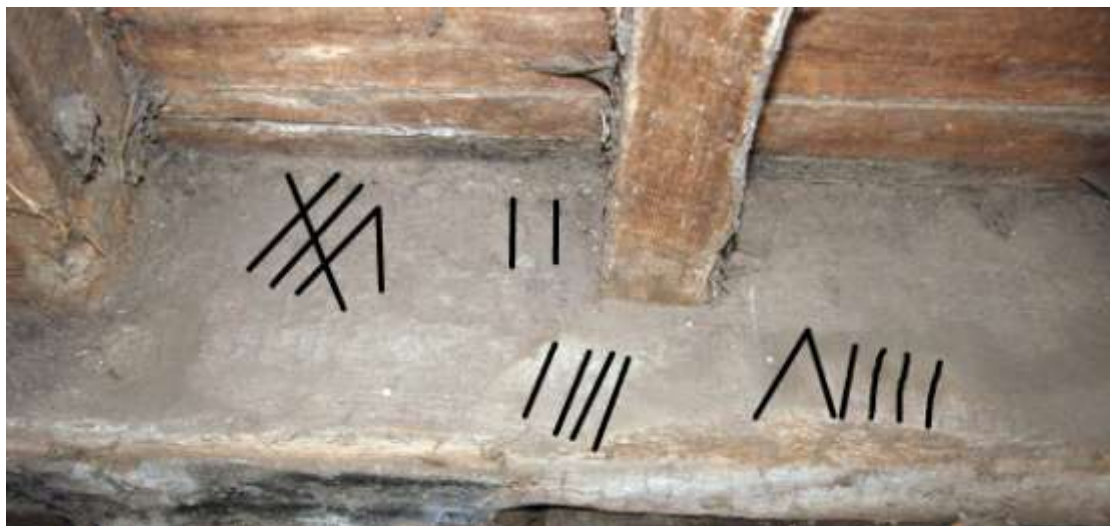
On the sole plate in Bay 6 there are four carpenters race knife marks - II, XXXV, IIII, IIIV all close together by the base of the principal posts of Truss 5. However this is softwood plate used in the construction of the new section and must have been put there post the 1942 explosion.

Carpenter's marks on the softwood sole plate in Bay 6. Enhanced in Photoshop CS2.

Finally race knife numbers II, XXXV, IIII, IIIV and XXX were used to mark the 1942 repairs. Evidently a traditional craftsman was on hand to do the work.

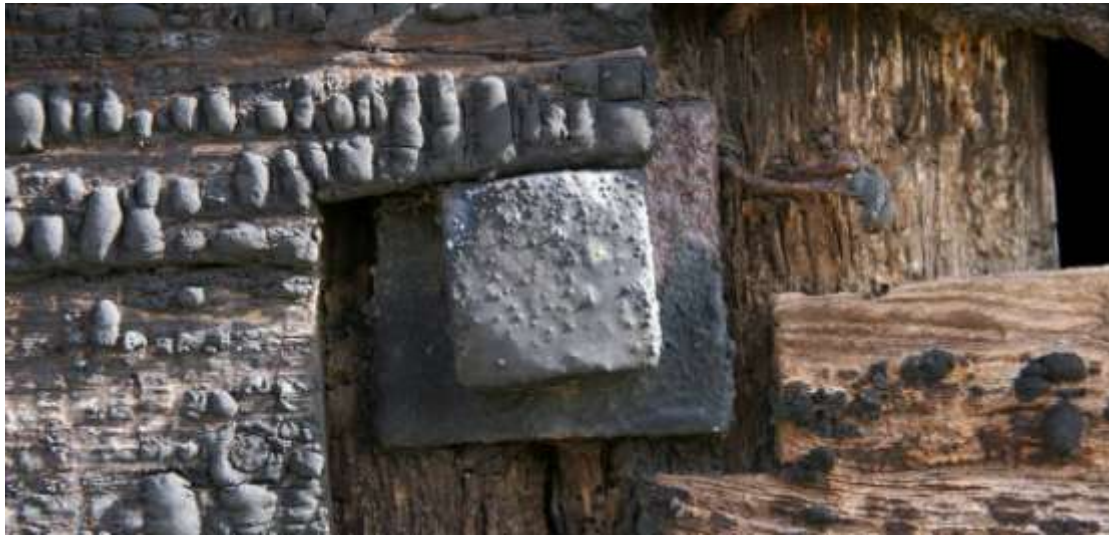
Head of a C19th / C20th bolt used to repair the barn.

Virtually all the ironwork repairs date from the C20th. There are a few long bolts with convex square heads and flat square nuts that date to the C19th but they are all in positions that denote reuse. This also applies to a few bolts which have near cubic heads and nuts which stylistically date to the C18th.

The iron ties that secure the tie-beams are all of mild steel and were formed, rather than forged. They again date to the C20th.

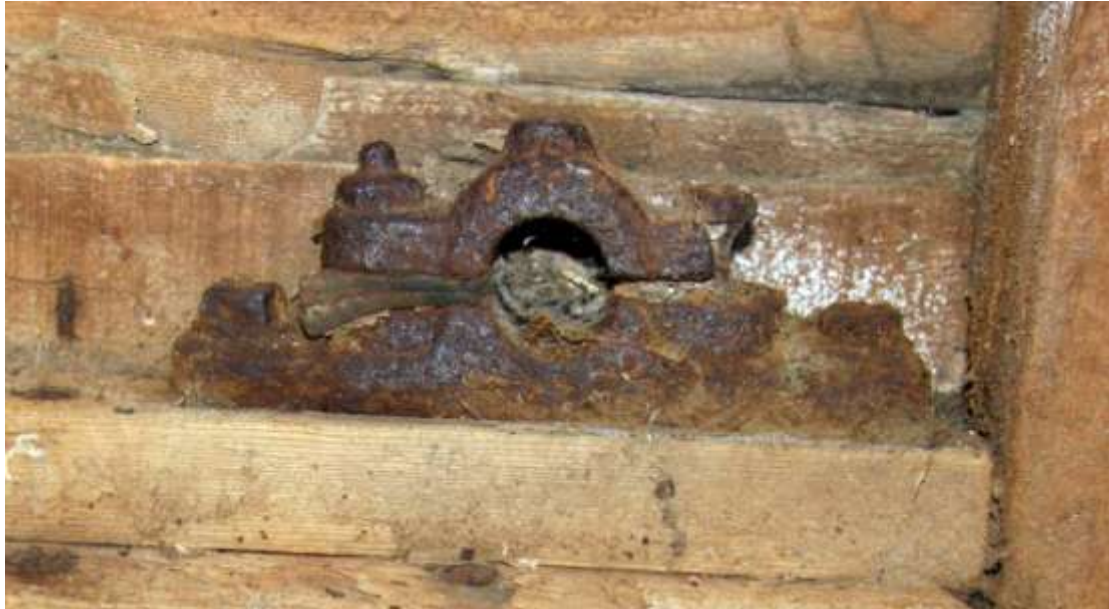
Bearing housing for a horse driven grinding machine still operating post 1942.

There is only one fixture inside the barn. This is a bearing housing for a shaft driven machine mounted on blocks on the sole plate in Bay 9 on the eastern side. This is a wholly repaired wall and so its operational use must post-date the repairs. It housed the shaft for a horse driven grinding machine used to grind grain to make animal feed. It was removed to make way for the Chicken House which was erected in 1965. (Mr David Chapman - pers comm).
